Integrity of Uranium Hexafluoride Cylinders

Defense Nuclear Facilities Safety Board

Technical Report

May 5, 1995

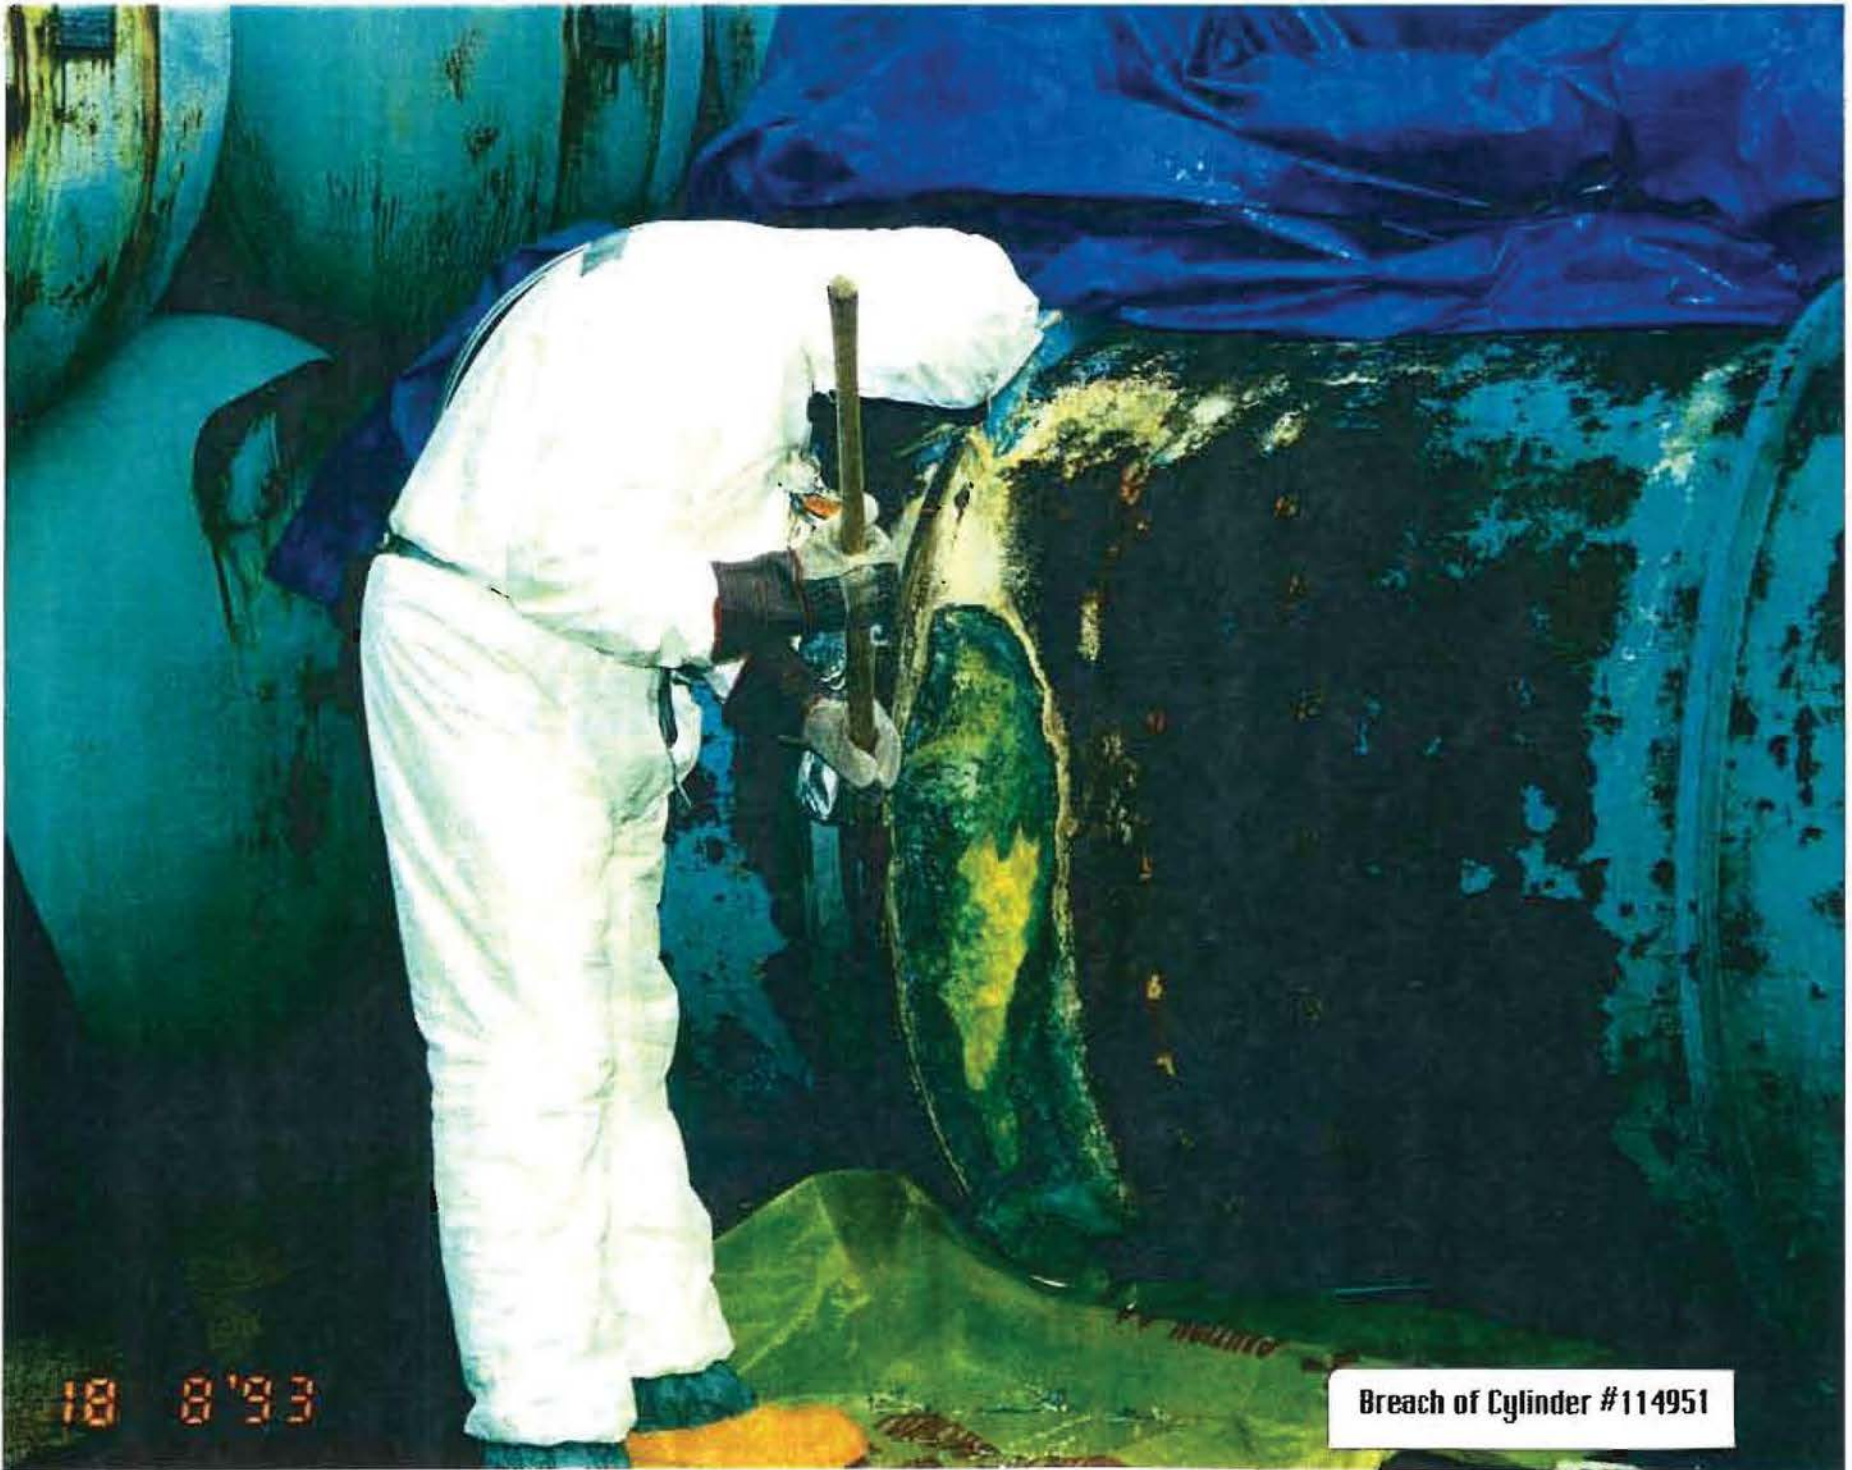
When released to the atmosphere, gaseous UF_6 reacts with water vapor to form a cloud of particulate UO_2F_2 and HF fumes. The reaction is fast, but is dependent on the availability of water. External contact with HF results in chemical burns of the skin, while exposure to airborne HF causes chemical burns/irritation of the eyes, nose, and throat. Because UF_6 reacts readily with water and organic materials, it must be handled in clean equipment and out of contact with moist air. A breach in a cylinder allows the external atmosphere to react slowly with the UF_6 . The solid reaction product tends to plug the breach; however, the HF formed releases slowly, attacks the metal cylinder, and enlarges the breach over time. The hole diameter is estimated to increase at a rate of approximately one inch per year. The reaction products, consisting of UF_4 , FeF_3 , and other iron oxides, fall to the ground or onto adjacent cylinders. The material released to the environment is HF and solvated uranyl fluoride $[H_3O]_2[U(OH)_4F_4]$, which is soluble in water. Figure 2. is a photograph of the largest breach discovered to-date.

Figure 2 Breached Cylinder at Oak Ridge K-25 Site

As described in the *Draft Preliminary Report of the DOE Independent UF₆ Cylinder Assessment Team*², the radioactivity UF₆ material depends upon the assay, but is approximately three curies per cylinder. Martin Marietta Energy Systems (MMES), the maintenance and operating contractor at all three sites, calculated that the amount of material lost by the largest cylinder breach (in Portsmouth) was about 110 pounds of UF₆. Neither this amount nor the amounts of material estimated lost from the other smaller breaches was reportable per EPA standards.
