June 18, 1997

SUBJECT: Work Planning and Conduct of Operations at the Hanford N Basin

MEMORANDUM
FOR: G. W. Cunningham, Technical Director
COPIES: Board Members
FROM: J. W. Troan
SUBJECT: Review of Work Planning and Implementation at Bechtel Hanford Incorporated (BHI) Activities

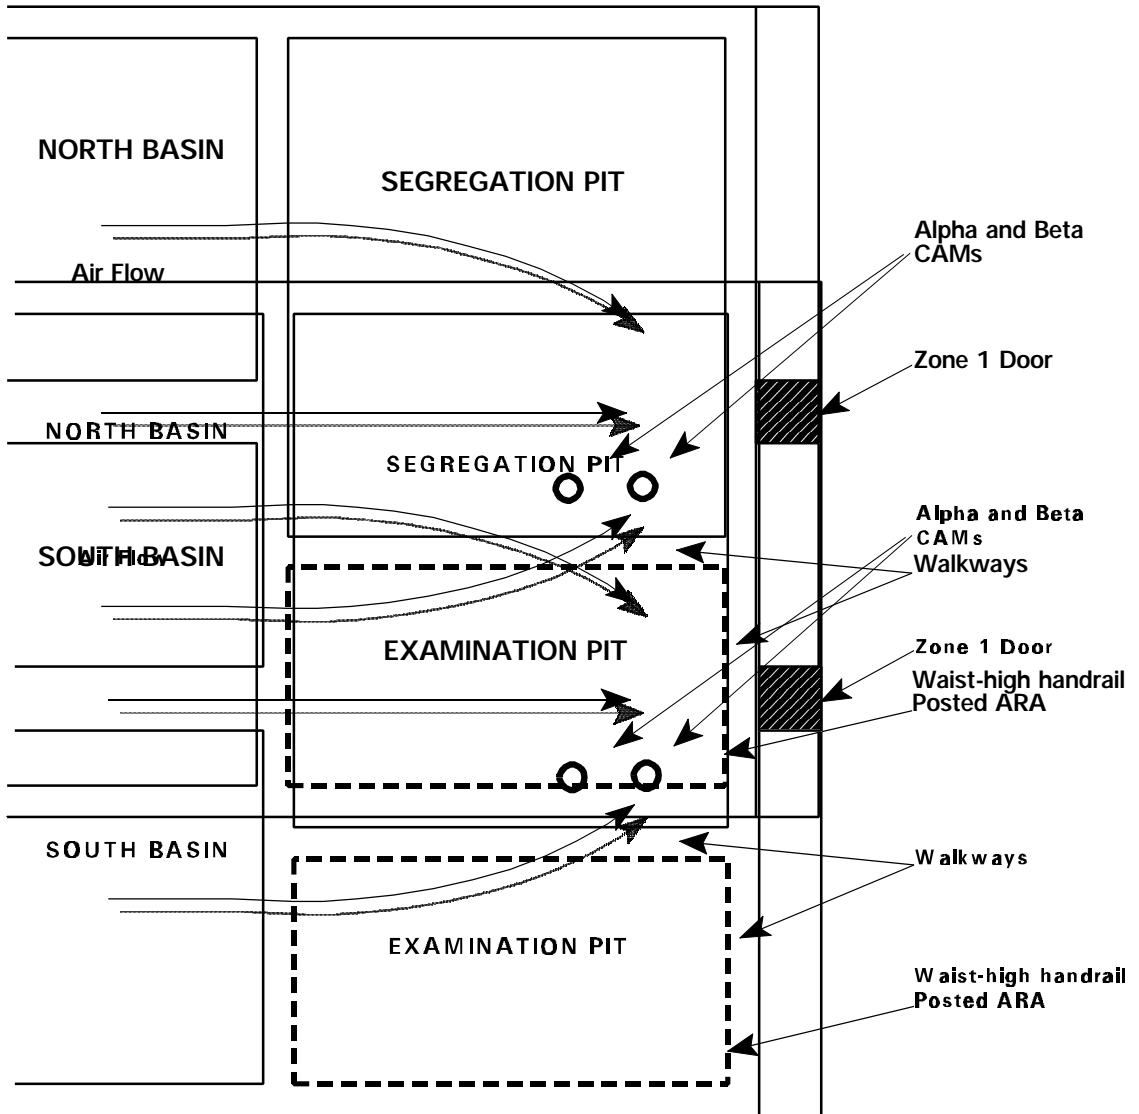
Airborne Radioactivity Postings. While touring the N Basin on March 27, 1997, the Board's staff observed airborne radioactivity area (ARA) postings on handrails that surrounded the Examination Pit (see

[Figure 1](#)). No physical barriers separated the air space of the posted airborne area from the unposted areas. The prejob briefing for the tour did not include mention of an ARA, nor was one identified on the radiological survey map. Walkways allowed access to basin areas that surrounded the posted area.

Upon further investigation, the Board's staff learned that N Basin management had stopped the cutting work (the near-miss event) requiring the postings, but that the radiological controls (radcon) organization had not authorized downposting of the area. Air samples taken after the work, which indicated potentially high airborne contamination levels, had not had sufficient time for the radon contribution to decay. Later, the radcon organization confirmed the presence of radon and removed the ARA postings.

Figure 1. N Basins, East End
