The purpose of this letter is to report the Department of Energy's (DOE) closure of the electrical safety issues at our Plutonium Finishing Plant (PFP) and at Hanford tank farms identified in your September 17, 2008, letter to the Assistant Secretary for Environmental Management.

Richland Operations Office Plutonium Finishing Plant Closure Project

Electrical Safety DNFSB Briefing

December 4, 2008

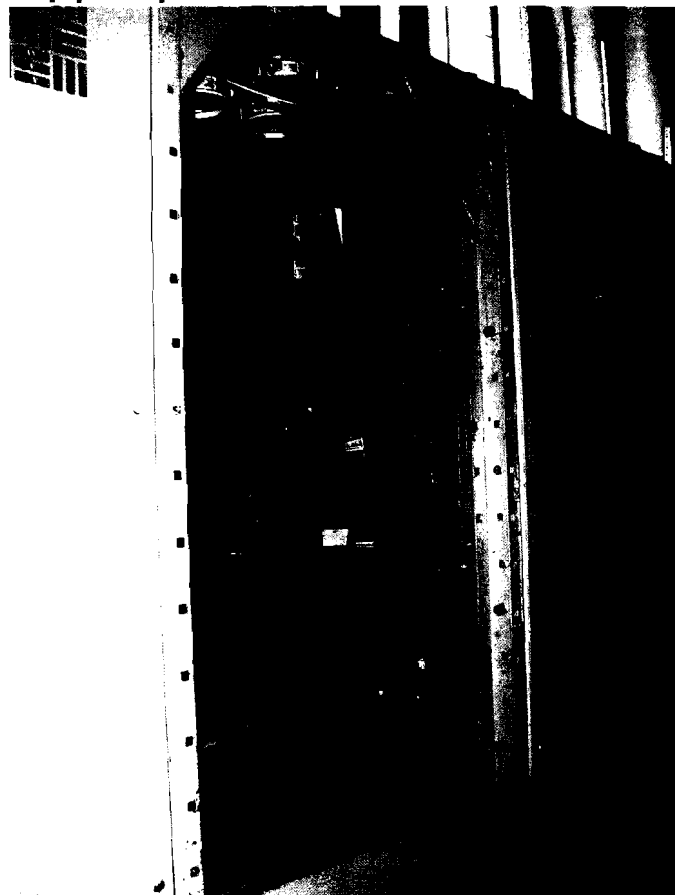
291-Z Switchgear enclosure.
Upper panel below water stains

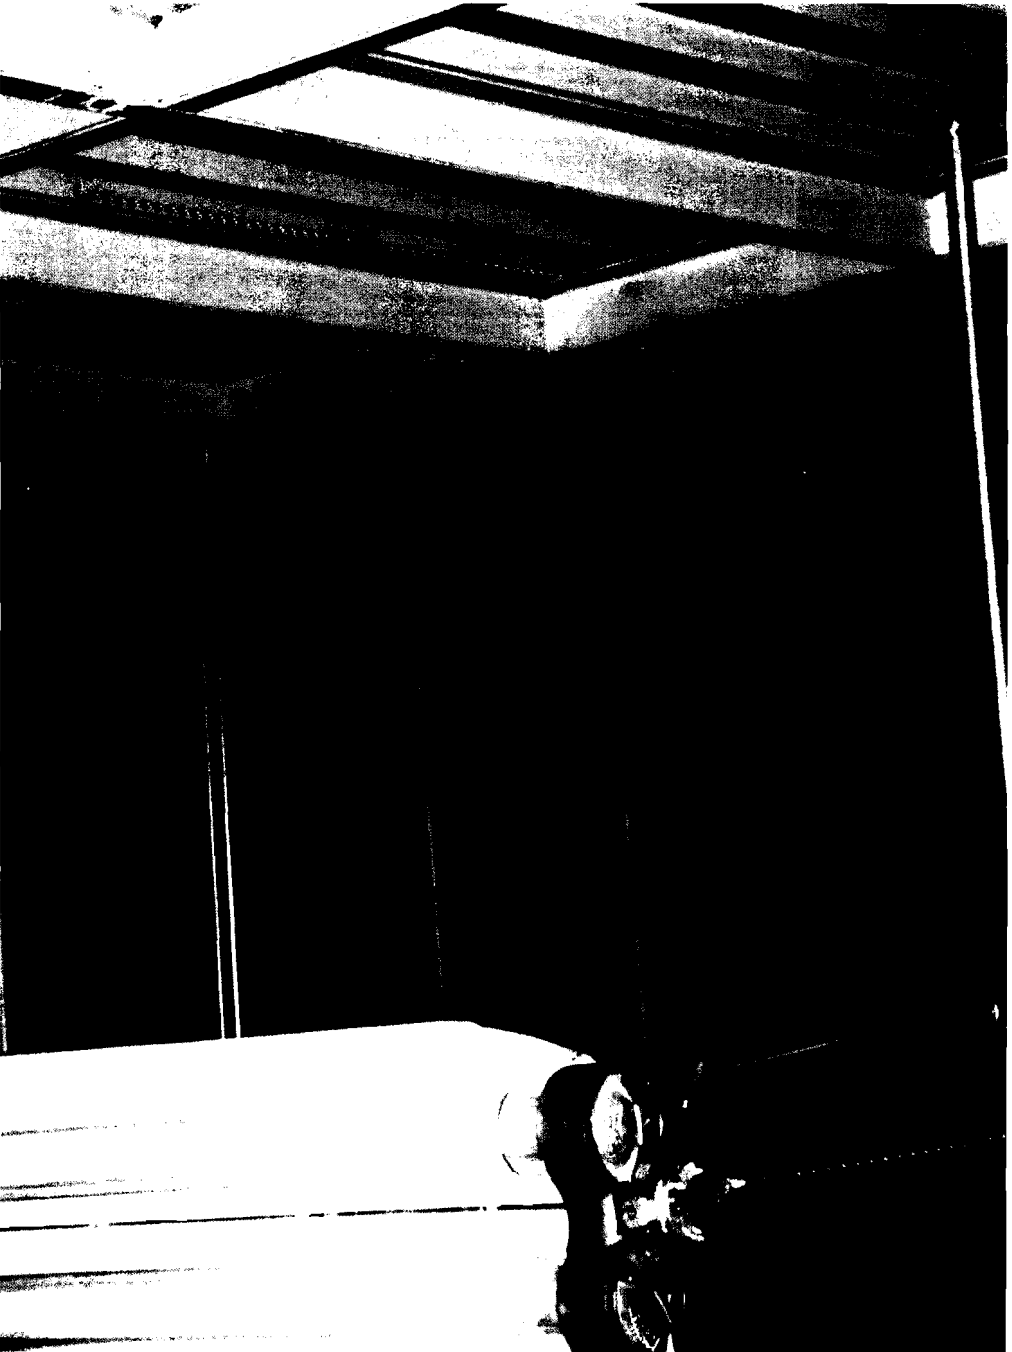
Room 269 HVAC Duct

- Hydrogen accumulation surveys, August 2008
 - No flammable gas detected
- Ventilation exchange rate survey, August 2008
 - High exchange rate
 - Active ventilation between duct and ceiling
- Low Hydrogen generation from batteries, per manufactures information
- Annunciation in 321 Control Room upon charging system failure
- Regularly scheduled checks of batteries (electrolyte, cell voltage, charging system, etc.) are conducted

Modifications are not needed to prevent accumulation of hydrogen in room 269.
