**DEFENSE NUCLEAR FACILITIES
SAFETY BOARD**

Staff Issue Report

December 10, 2014

SUBJECT: Review of the System Back Out Plan and Ventilation System for the Plutonium Finishing Plant Project

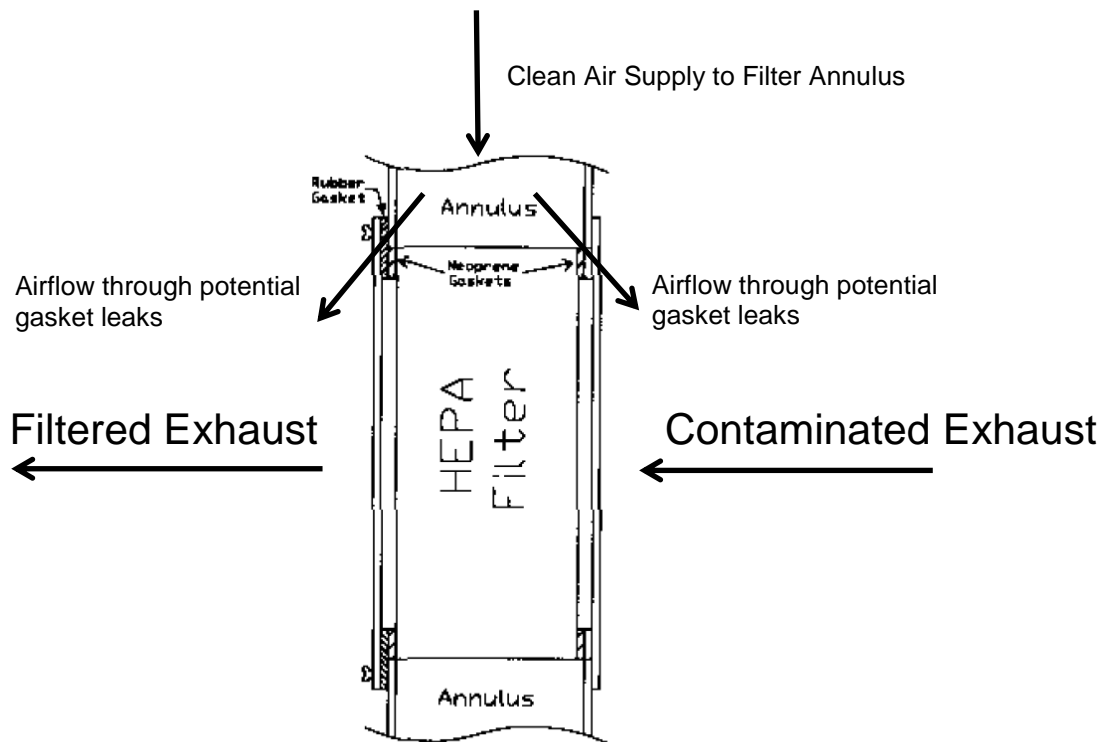
Figure 1. PFP HEPA Filter Design

The PFP HEPA filter plenum includes a unique capability to mitigate the effects of potential leakage around the HEPA gaskets that seal the filter to the plenum (see Figure 1). The design includes a gasket on the up and downstream faces of each filter, creating an annular space around the filter case. For ~45 years, a separate air supply system provided the annular space with clean, pressurized air to ensure that any gasket leaks resulted in the flow of clean air into the filter plenum rather than the flow of contaminated exhaust air around the filter gaskets. In the mid-1990s, PFP personnel terminated operation of the system's supply fan due to high vibration. The supply system continued to operate passively, relying on the negative pressure in the filter plenum to pull clean air from the supply system through any gasket leaks. Over time, the HEPA gasket seals deteriorated and flow through the supply system increased. Recent repairs and changes in damper position have reduced the flow through the system to a negligible level.

The PFP TSR requires an annual aerosol leak test of the HEPA filters to ensure that leakage around or through the filters remains within the limits prescribed by the safety basis. The review team questioned the adequacy of the leak test to detect leakage around the filters given their unique design. Specifically, because the supply system communicating with the annular space around the filters provides clean air to any leak sites, the aerosol leak test would not be capable of detecting a potential leak path around the filters (i.e., the influx of clean air

would preclude test aerosol from leaking past the gaskets). The only indication available to detect HEPA gasket degradation, and thus the potential for bypass leakage, is a differential pressure gauge on the supply system that provides a crude estimate of the airflow leaking through the gaskets into the filter plenum. The TSR, however, does not establish requirements to monitor this flow. Consequently, the review team concluded that the TSR does not establish an adequate surveillance for confirming HEPA filter operability.

The review team expressed further concern that the system configuration could lead to an unanalyzed bypass leakage condition during accidents that result in high filter loading such as a major fire. As HEPA filters load with particulate during an accident, the ventilation control system maintains the pressure upstream of the HEPA filters constant while the pressure downstream becomes more negative. The increasing pressure drop across the HEPA filters could facilitate a bypass leakage pathway around the filters if the gaskets are not leak tight and the leakage through the downstream gasket is sufficient to draw the annular space negative with respect to the plenum upstream of the HEPA filters.

The review team acknowledges that significant dilution would be expected for any bypass leakage due to the elevated release from PFP's stack. However, the review team concluded that the bypass scenario could challenge the efficiency credited in the DSA for the safety-significant HEPA filters. CHPRC and DOE-RL personnel did not disagree with this concern. Before committing to address it, they are reviewing previous technical analyses that they believe evaluated potential bypass leakage pathways. They committed to providing the staff with the results of their investigation upon completion.
