**DEFENSE NUCLEAR FACILITIES  
SAFETY BOARD**

## Staff Issue Report

January 29, 2016

**SUBJECT:** Seismic Qualification of Fire Suppression System at the Plutonium Facility, Los Alamos National Laboratory

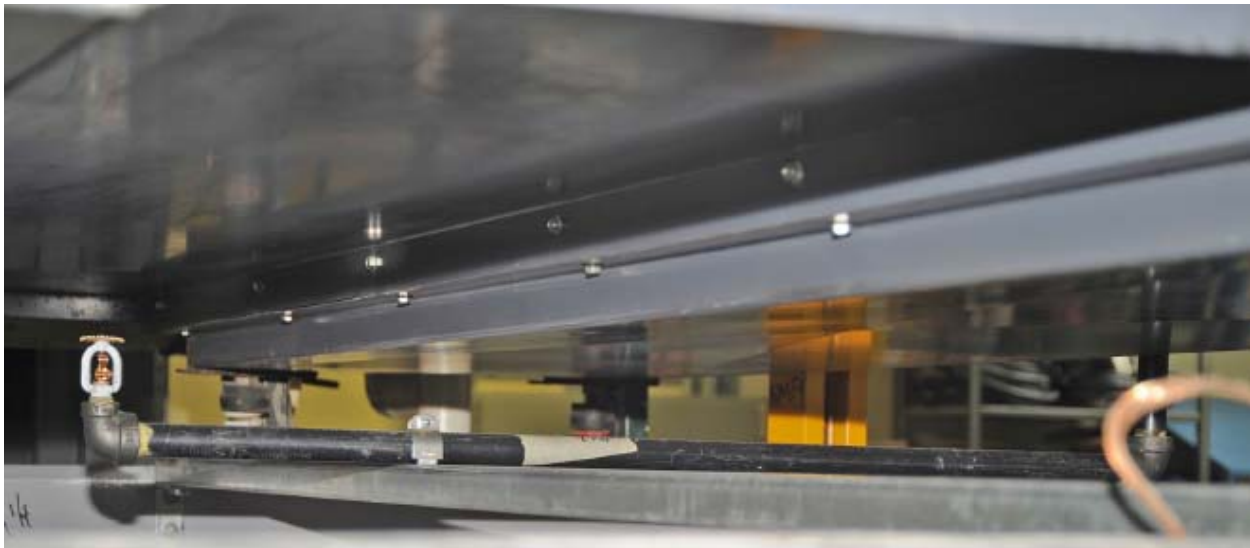
During the November 30, 2015, walkdowns, the staff review team found that a number of the seismic interaction concerns identified by LANS in 2010 still existed [5]. Most notably, large air handlers were installed above fire suppression piping without adequate seismic anchorage and bracing (Figure 1). Damage to the fire suppression piping from falling equipment, such as these air handlers, would lead to a loss of water and hydraulic pressure in the facility, impairing its function after a seismic event. The site's structural engineers could not provide the staff review team with a technical justification for why this condition does not pose a seismic interaction concern. They acknowledged that not all seismic interaction effects have been dispositioned for the FSS.

**Figure 1: Example of fire suppression piping underneath unsecured equipment.**

The Project Execution Strategy (PES) for TA-55 currently estimates completion of walkdowns to identify seismic interaction concerns in July 2016; however, there is no schedule associated with the disposition of any identified seismic interactions that may impair fire suppression function after a seismic event. The staff review team is concerned that not including a schedule to resolve these issues may delay and complicate crediting the FSS for post-seismic fires at PF-4.

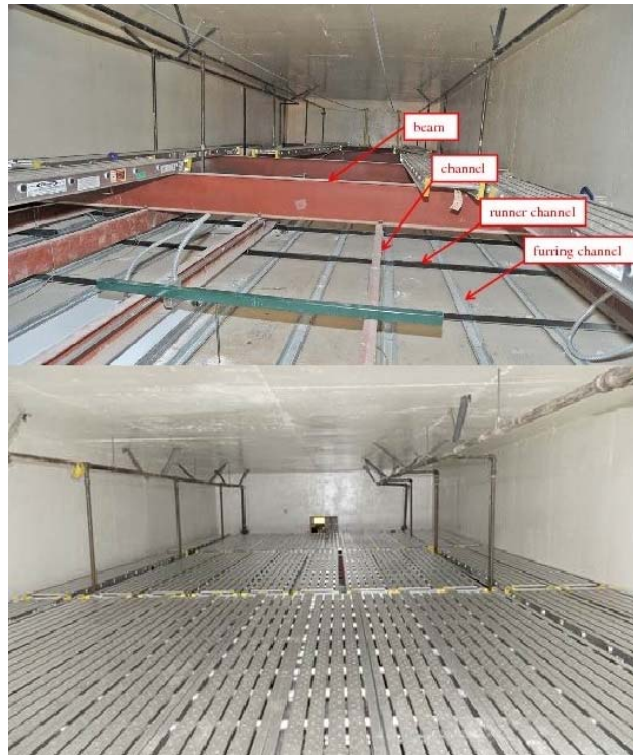
*Configuration Changes to Laboratory Ceilings*—During walkdowns of PF-4, the staff review team viewed one of the laboratory ceiling spaces where LANS has made fire suppression and structural upgrades to the roof girders. Damage or collapse of parts of the laboratory ceiling during an earthquake may damage fire suppression piping and prevent the proper heat activation of sprinkler heads during a post-seismic fire. The staff review team noted that LANS installed significant metal decking that is supported by the laboratory ceiling (Figure 2). This differs from the facility configuration assumed in the seismic evaluation performed in 2011 by LANS's subcontractor [6]. Facility engineers told the staff reviewers that these changes are intended to be permanent.

When asked if this significant increase in dead load and seismic mass added to the laboratory ceilings had been accounted for, LANL staff engineers said that they had not updated this calculation with the configuration changes made since 2011, but believed the added decking would not exceed the dead load assumptions used in the calculations. In further discussions, LANS engineers estimated that the metal decking mass will not challenge the assumed miscellaneous loads on the laboratory ceiling. This condition was not formally evaluated before installation of the decking, and is a lapse in configuration management of the laboratory ceiling. The *Nuclear Safety Management Rule* (10 CFR Part 830) requires evaluating the impacts of configuration changes on safety-related SSCs before they are made [7]. Consistent with the rule, the staff believes that unanalyzed conditions, such as the metal decking, should have been evaluated through the LANS Unreviewed Safety Question process.

**Figure 2: Condition of laboratory ceiling as evaluated (top) and current configuration (bottom).**
