Part One

The Accident

Part One of the report of the Columbia Accident Investigation Board is organized into four chapters. In order to set the background for further discussion, Chapter 1 relates the history of the Space Shuttle Program before the *Challenger* accident. The events leading to the original approval of the Space Shuttle Program are recounted, as well as an examination of some of the promises made in order to gain that approval. In retrospect, many of these promises could never have been achieved. Chapter 2 documents the final flight of *Columbia*. As a straightforward record of the event, it contains no findings or recommendations. Chapter 3 reviews five analytical paths – aerodynamic, thermodynamic, sensor data timeline, debris reconstruction, and imaging evidence – to show that all five independently arrive at the same conclusion. Chapter 4 describes the investigation into other possible physical factors that might have contributed to the accident, but were subsequently dismissed as possible causes.

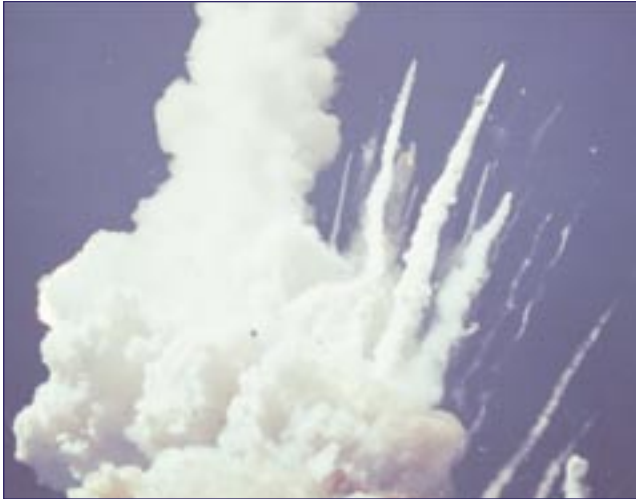
Figure 1.5-1. the Space Shuttle Challenger was lost during ascent on January 28, 1986, when an O-ring and seal in the left Solid Rocket Booster failed.

The Rogers Commission report, issued on June 6, 1986, recommended a redesign and recertification of the Solid Rocket Motor joint and seal and urged that an independent body oversee its qualification and testing. The report concluded that the drive to declare the Shuttle operational had put enormous pressures on the system and stretched its resources to the limit. Faulting NASA safety practices, the Commission also called for the creation of an independent NASA Office of Safety, Reliability, and Quality Assurance, reporting directly to the NASA Administrator, as well as structural changes in program management.²⁰ (The Rogers Commission findings and recommendations are discussed in more detail in Chapter 5.) It would take NASA 32 months before the next Space Shuttle mission was launched. During this time, NASA initiated a series of longer-term vehicle upgrades, began the construction of the Orbiter *Endeavour* to replace *Challenger*, made significant organizational changes, and revised the Shuttle manifest to reflect a more realistic flight rate.

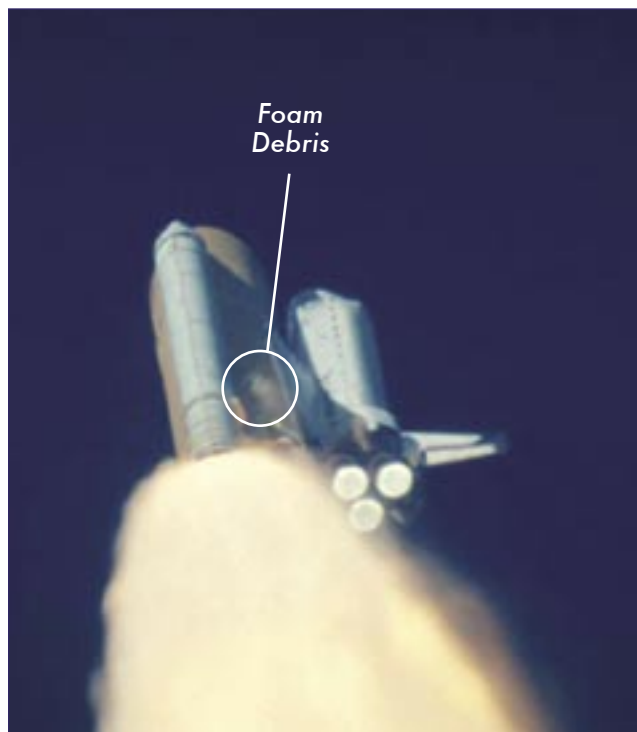
Figure 2.3-2. A shower of foam debris after the impact on *Columbia's* left wing. The event was not observed in real time.

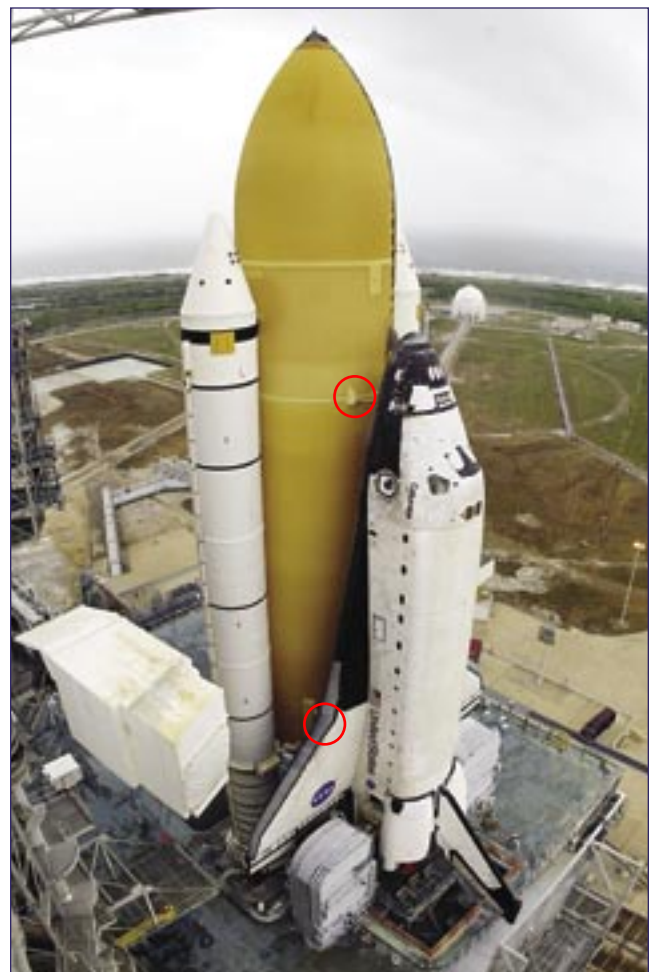
Figure 3.1-1. Columbia sitting at Launch Complex 39-A. The upper circle shows the left bipod (-Y) ramp on the forward attach point, while the lower circle is around RCC panel 8-left.

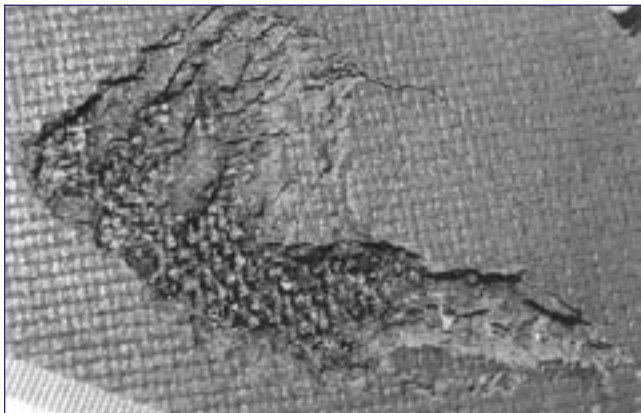
Figure 3.3-2. Damage on the outer surface of RCC panel 10-right from *Atlantis* after STS-45.

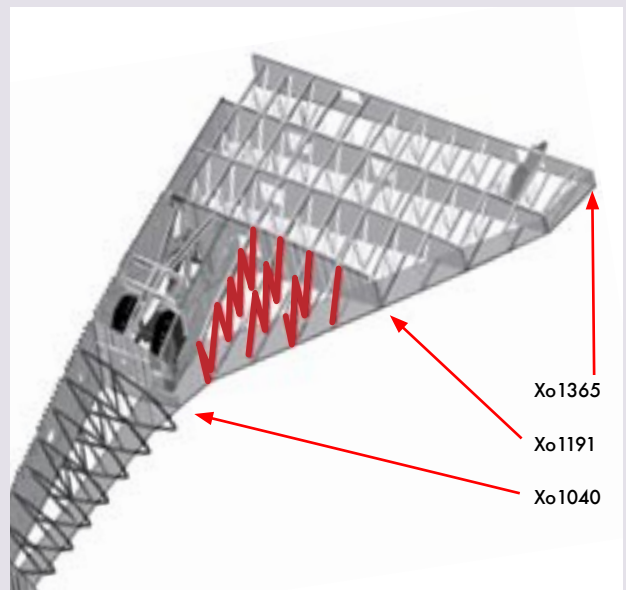
The major internal support structures in the mid-wing are constructed from aluminum alloy. Since aluminum melts at 1,200 degrees Fahrenheit, it is likely these truss tubes in the mid-wing were destroyed and wing structural integrity was lost.

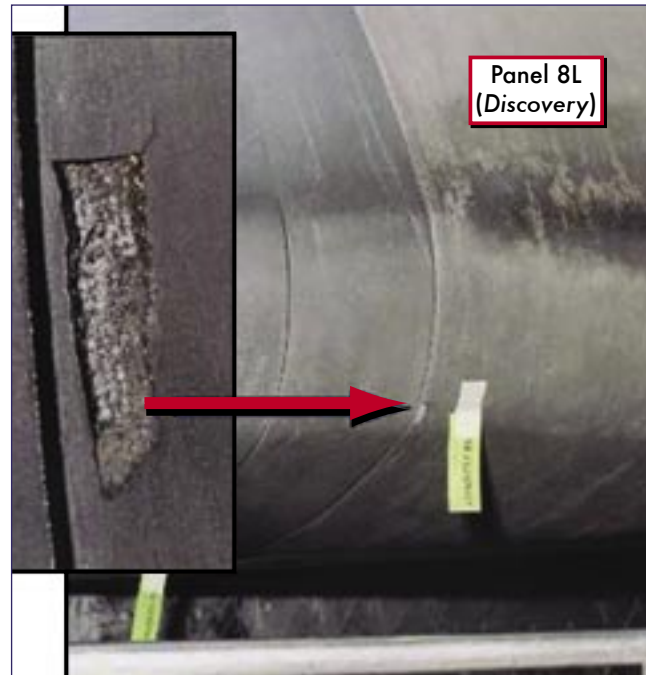
Figure 3.3-5. RCC panel 8-left from *Discovery* had to be scrapped after STS-103 because of the damage shown here.

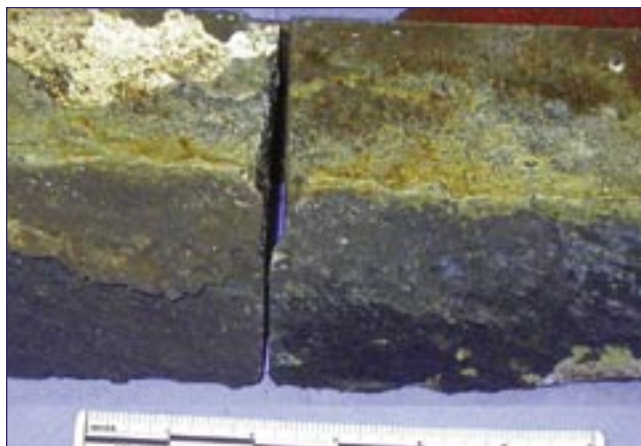
Figure 3.7-3. Superheated airflow caused erosion in tiles around the RCC panel 8 and 9 interface. The tiles shown are from behind the area where the superheated air exited from the slot in Figure 3.7-2. These tiles showed much greater thermal damage than other tiles in this area and chemical analysis showed the presence of metals only found in wing leading edge components.

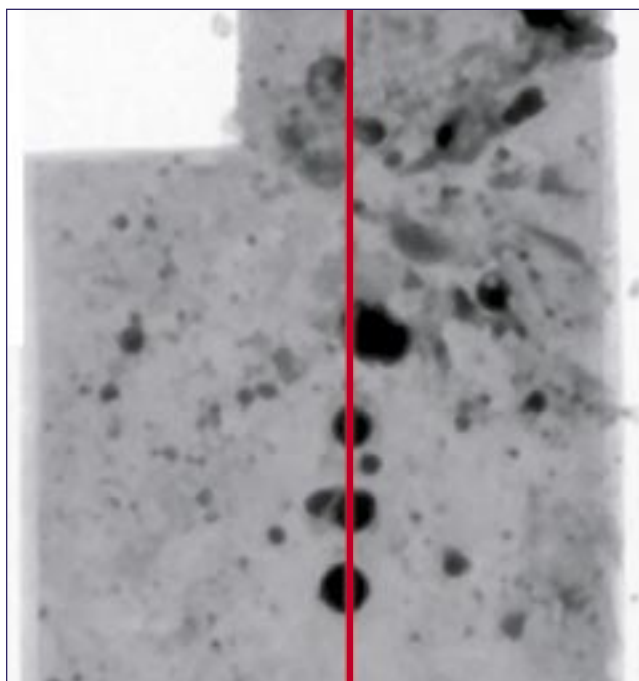
Figure 3.7-7. X-ray analysis of RCC panel 8-left showed a bottom-to-top pattern of slag deposits.

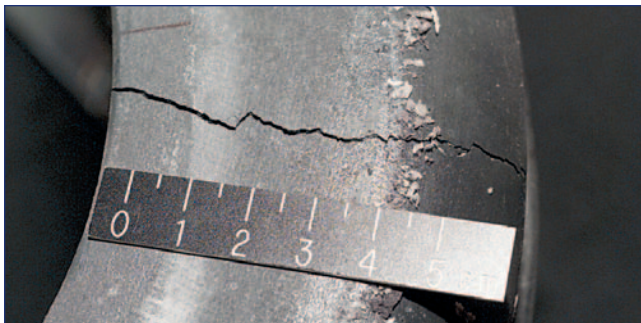
Figure 3.8-6. A 5.5-inch crack on the outboard portion of RCC Panel 6 during testing.

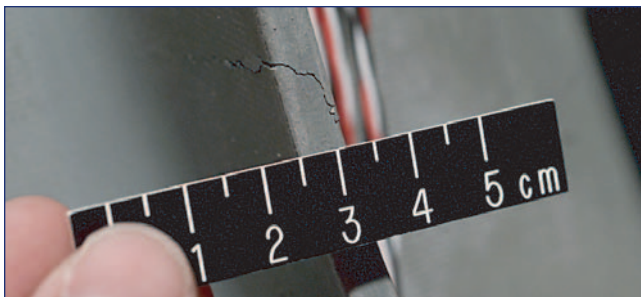
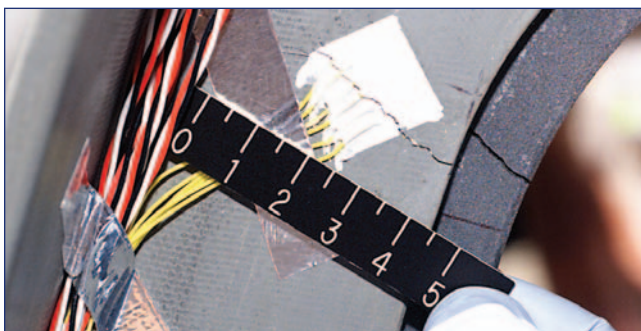
Figure 3.8-7. Two views of the crack in the T-seal between RCC Panels 6 and 7.

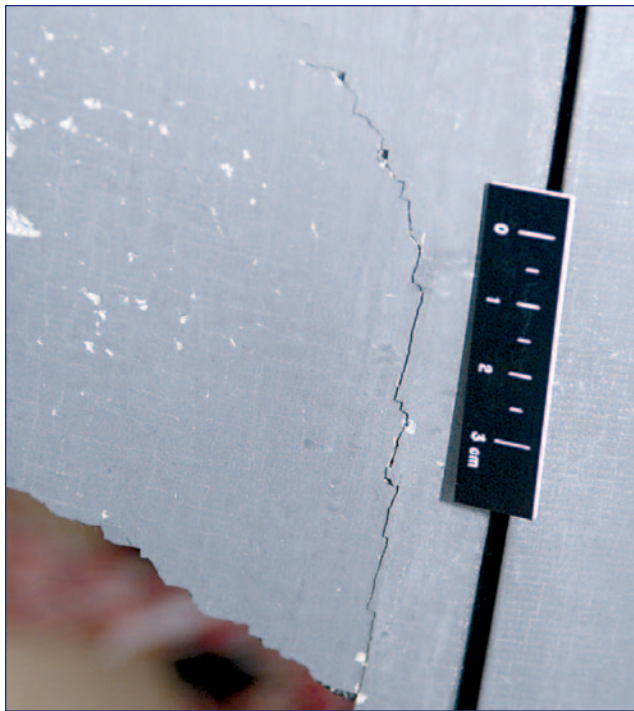
Figure 3.8-10. Numerous cracks were also noted in RCC Panel 8.
