# Storage Conditions of Reactive Metal Fuel in L-Basin at the Savannah River Site

## Defense Nuclear Facilities Safety Board Technical Report

January 2013

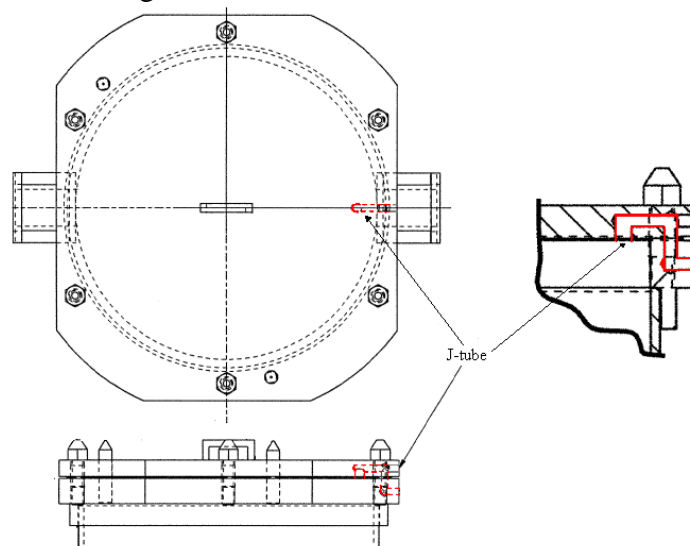
- A J tube can has a tube on the top of the can that is bent into the shape of an inverted J or U. The bend is filled with gas while the can itself is filled with water. The tube is open ended to allow any gas generated inside the can to escape. The gas pocket inside the tube prevents water inside the can from mixing with water outside the can. Since J tube cans are filled with water, water may be able to react with any exposed reactive metal fuel. Any soluble fission products that leach out of the fuel or insoluble corrosion products will remain inside the J tube can since the water inside the can is isolated from the surrounding water. J tube cans may be small inner cans or larger outer cans like the HWCTR and L oversized cans. Figure 1 illustrates an example of a J tube can design.

**Figure 1. A J tube can design.**

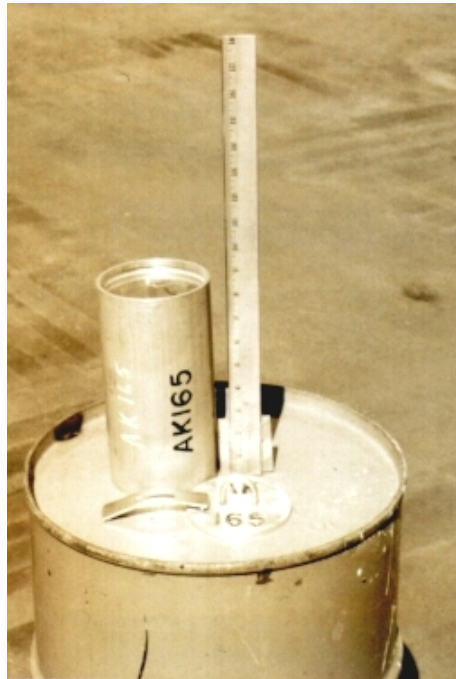
- K can—A 9-inch-long aluminum can with a mechanical seal. A plate on top of the can is held in place with an aluminum bar. The top plate has a metal-to-metal seal with the can body, and the bar is wedged on top of the plate to hold the plate down and keep water out. See Figure 2.
- Slug can—A small can used to store fuel slugs. All slug cans have a small hole in the lid that allows water to enter.
- Z can—A long aluminum can that uses a plate and bolts to form a mechanical seal at the top. See Figure 3.

**Figure 2.** A new K can sitting on a drum next to a ruler.

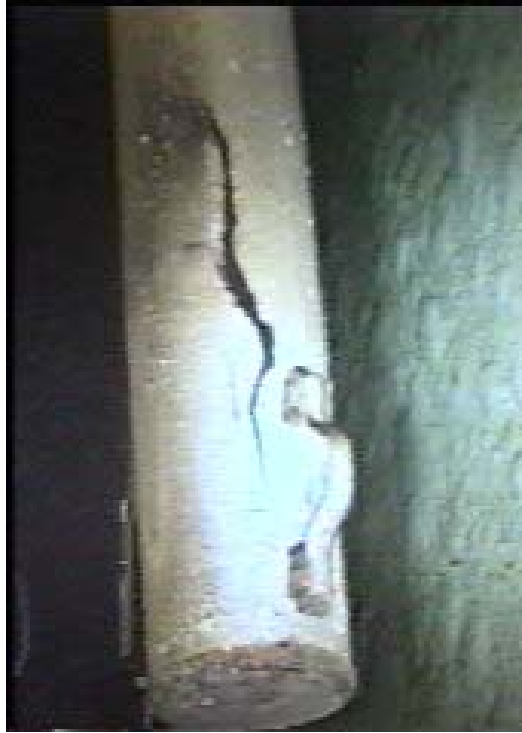
**Figure 3. Lower portion of a cracked Z can.**

- Four L oversized cans contain a total of six Z cans, including the three that previously failed. The Z cans have a plate wedged in on top that is held in place with a bolt. Bubbles are being released from the vents of these four L oversized cans, including those that contain only Z cans that were still intact in 2002. This indicates that the fuel in the breached Z cans is still reacting with water and that additional Z cans have failed since they were initially repacked.
- Two L oversized cans contain intact fuel assemblies. The assembly in one L oversized can is in direct contact with water, while the other assembly is inside a sealed can. An inspection found no bubbles being released during the observation period. This could mean that the cladding or can seal may still be protecting the uranium metal or that the reaction is slow or has stopped.

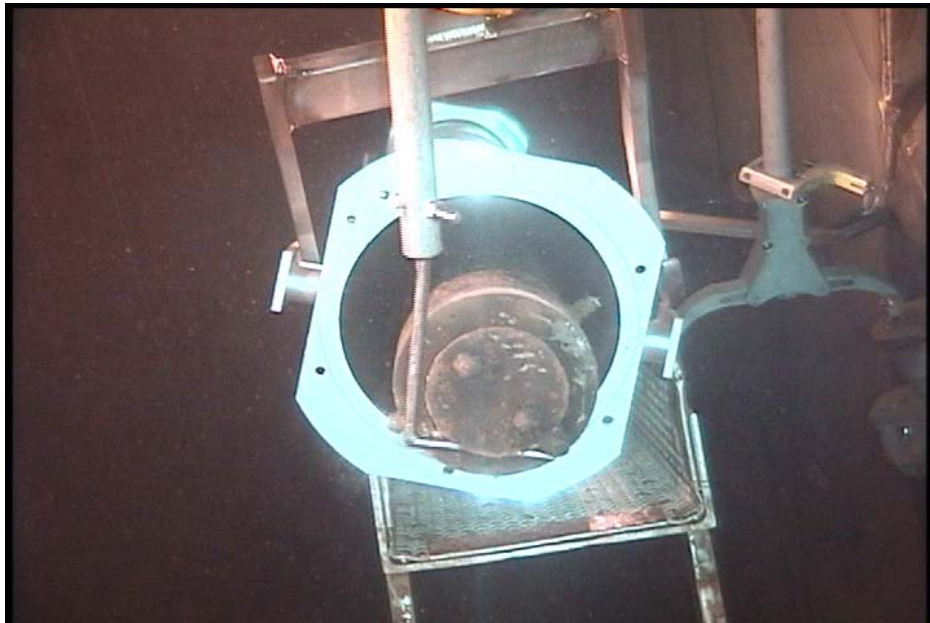
Small inner cans like K and slug cans may be stacked inside a FEC. The FEC is a 5-inch-diameter, 12-foot-long aluminum can that has an open vent tube on top. The FEC is then stored inside a HWCTR or L oversized can. See Figure 4.

**Figure 4. A failed element container being loaded into an L oversized can.**

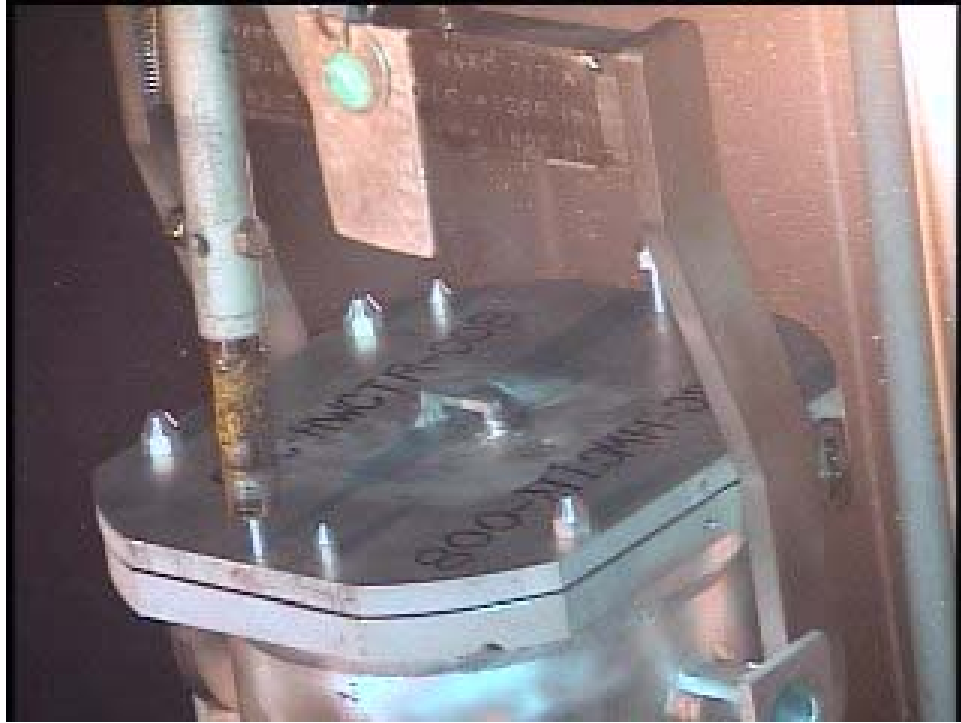
- HWCTR oversized can—A 14-inch-diameter, 14-foot-tall older outer can made of either aluminum or stainless steel, equipped with connections for sampling and flushing, that is no longer used. See Figure 5.
- L oversized can—Currently used as an outer can, it is similar to the HWCTR oversized can but only 8 inches in diameter. These aluminum cans have J tubes, but no connections for sampling or flushing. See Figure 6.
- L bundle—A 5-inch-diameter, approximately 11-foot-long aluminum tube currently used as an outer can. The bottom plate and lid each have eight 0.25-inch diameter holes that allow the basin water to enter. See Figure 7.

**Figure 6. Installing the lid on an L oversized can.**

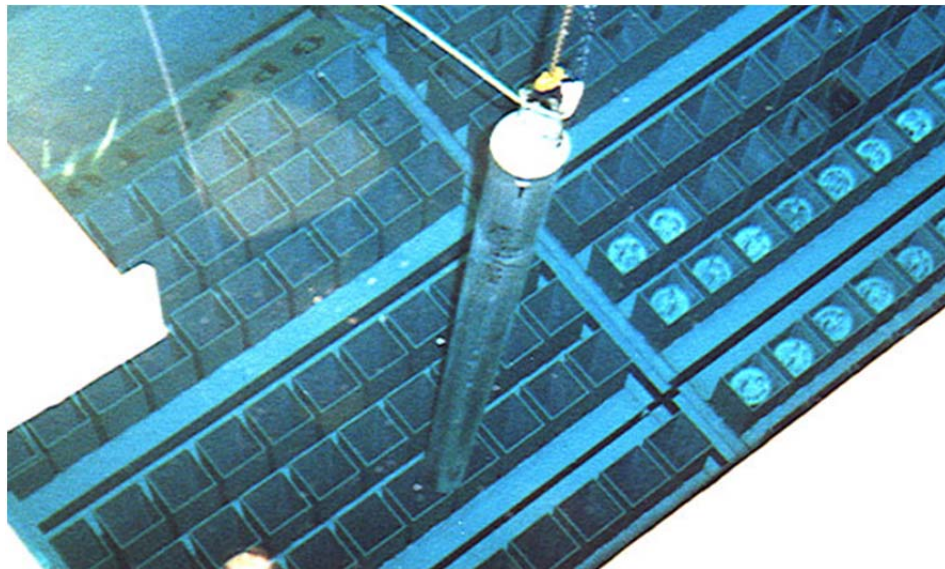
**Figure 7: An L bundle being raised above storage racks.**

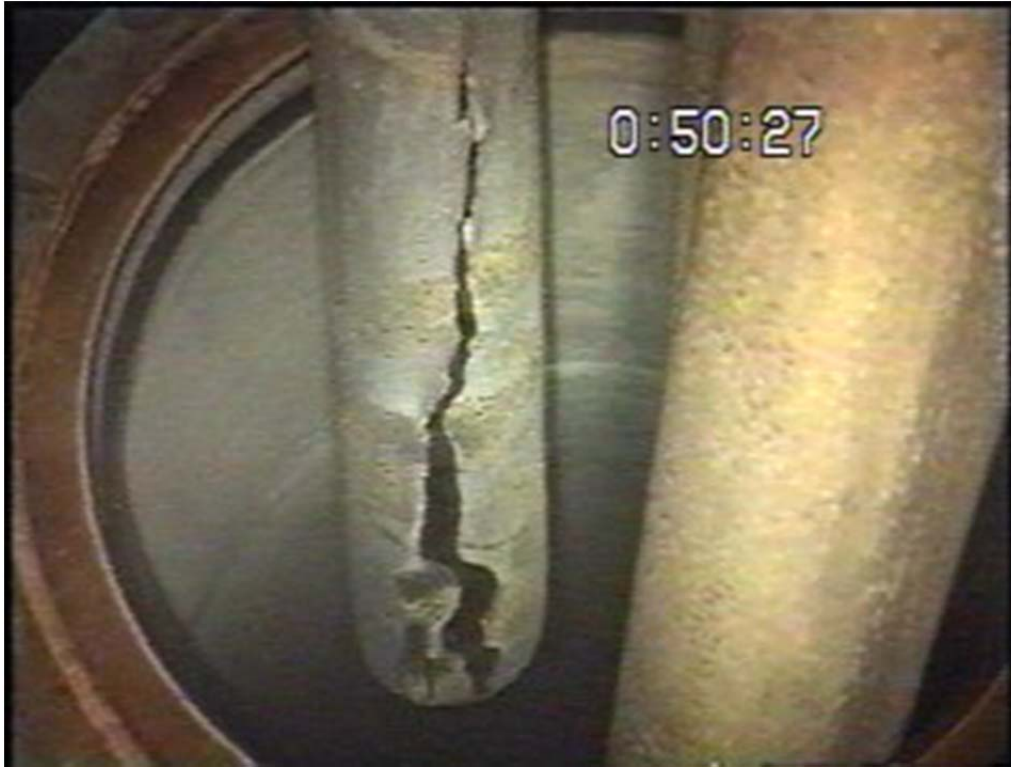
After approximately 30 years of storage at RBOF, DOE deinventoried RBOF between 1997 and 2003 and moved all of the HWCTR fuel assemblies to L-Basin. As part of this effort, DOE repacked the fuel assemblies from the original HWCTR oversized cans into smaller L oversized cans. DOE flushed several HWCTR oversized cans to remove the radionuclides that had accumulated in the water within the cans as a result of degradation of the SNF. These HWCTR oversized cans were opened, at which time it was noted that half of the Z cans inside were cracked (see Figure 8). The cracks allowed water to enter the cans and react with the uranium metal fuel to form uranium oxide and possibly uranium hydride. In one case, the corrosion of the metal fuel resulted in the deposition of 36 pounds of corrosion products at the bottom of just one HWCTR oversized can. In addition, the water leached out soluble fission products such as cesium-137 (Cs-137). Therefore, DOE decided to flush several of the HWCTR oversized cans using an underwater pump, pre-filter, and resin deionizer system. This process captured 319 curies of leached Cs-137 in the resin and an additional 12 pounds of corrosion product fines in the filter. Although DOE placed the cracked cans inside new L oversized cans, the damaged fuel remains in contact with water, where it can continue to degrade. DOE also packaged the pre-filters, the ion exchange resin, and the corrosion products at the bottom of the worst HWCTR oversized can into cans with J tubes and shipped them to L-Basin because it had no way to handle them. DOE loaded all of the other J tube cans in RBOF and the small sealed cans in the buckets into L bundles.

**Figure 8. Cracked Z can inside an HWCTR oversized can.**

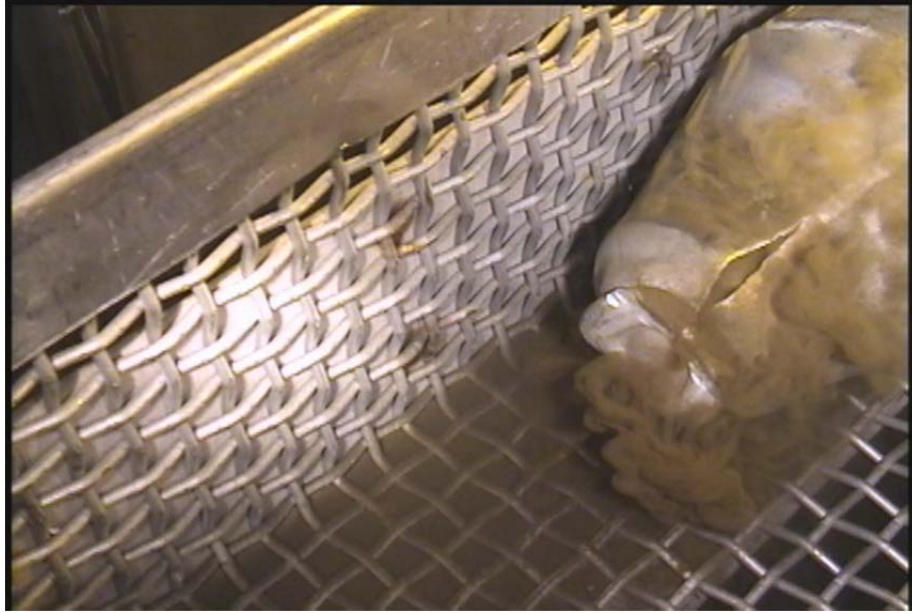
- Several L bundles contain one or more K cans.
- Seven L bundles each contain a fuel assembly inside a sealed aluminum tube with a J tube vent in the lid. Some of the assemblies are intact, while others have ruptured cladding. The metal fuel in each of the tubes is in contact with water. During the RBOF deinventory campaign, DOE found that one of the tubes had failed (see Figure 9). All of these items were placed in L bundles that were modified to include a solid bottom to contain corrosion products and a zeolite filter in the lid to capture cesium that was released.

**Figure 9. Sealed tube with crack at bottom.**

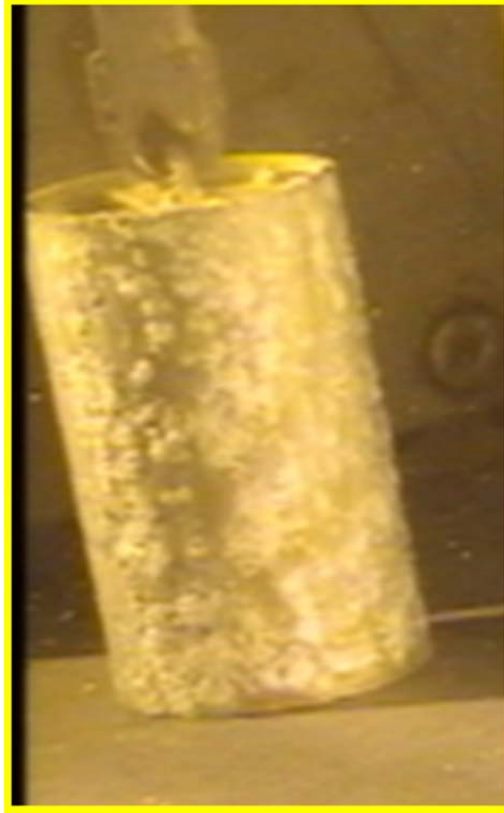
Nearly all the inner cans containing metal fuel are approximately 50 years old, and DOE is considering the possibility of extended storage of these cans for an additional 50 years (U.S. Department of Energy Savannah River Operations Office, 2011a). Many of these cans were stored in P-Basin and R-Basin for 6 to 12 years (see Figure 10). The water in these basins was untreated, filtered river water. Even though the L oversized cans and L bundles are now stored in L-Basin, which is filled with treated water, the water inside the L oversized cans and the smaller J tube cans inside L bundles is isolated from the basin water. Thus, the water contained in the smaller J tube cans stored in L bundles is the water present in P-Basin and RBOF when the cans were loaded in the 1960s and 1980, while the water in the L oversized cans is from RBOF 10 years ago. Although the L bundles have holes in the lids and some bottom plates to allow basin water to enter, the amount of mixing is limited by the ¼-inch size of the holes; the long, narrow shape of the tube; the obstructions caused by the inner cans or fuel assemblies; and the relatively low decay heat of the fuel, which would not create much of a thermal gradient to drive convection. The current designs of the L oversized cans and the smaller J tube cans do not allow the water inside to be sampled or flushed.

**Figure 10. Aluminum can previously exposed to P-Basin water.**

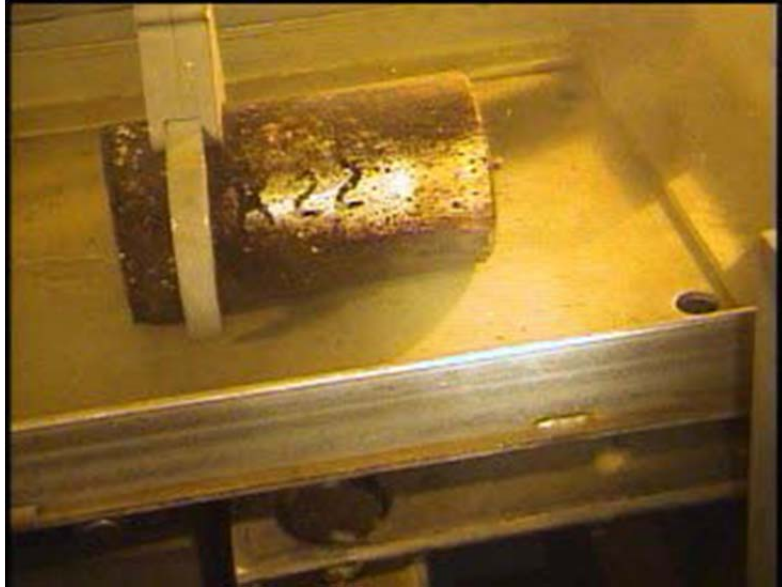
DOE has very limited data on the condition of the various cans in use. During the RBOF deinventory campaign a decade ago, DOE was able to inspect the exterior of the small cans in the RBOF buckets along with two small cans, FECs, and Z cans inside the HWCTR oversized cans. DOE noted substantial surface pitting (see Figures 11 to 13). Once pitting has begun on the surface of a storage container, the local electrochemical conditions within the pit, not the bulk chemical composition of the fluid outside the pit, drive continued pit penetration into the metal. Once initiated in the storage cans, pits can continue to propagate regardless of the purity of the water within the L oversized can or L bundle.

**Figure 11. K can with evidence of pitting from one of the HWCTR oversized cans that did not require flushing.**

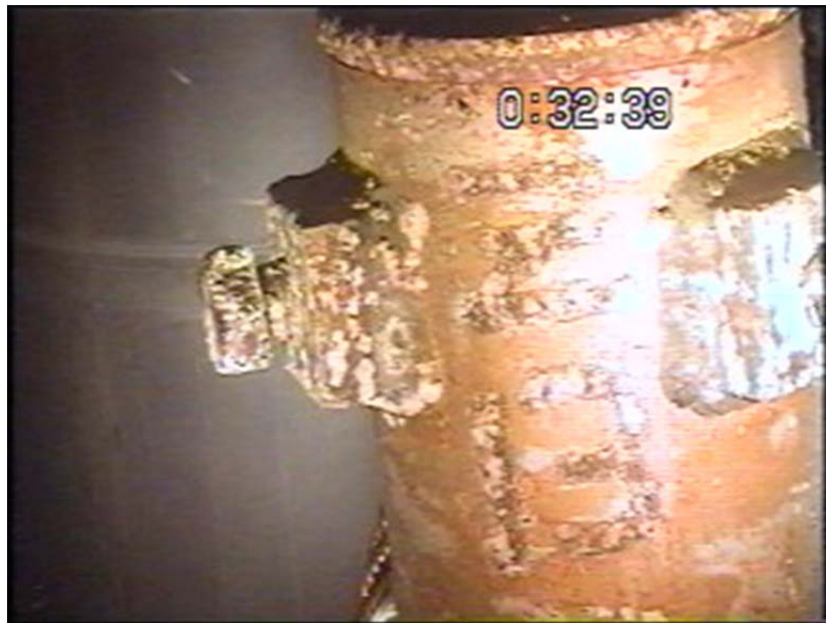
Note: This is not one of the three cracked Z cans.

**Figure 12. Z can with evidence of pitting removed from an HWCTR oversized can.**

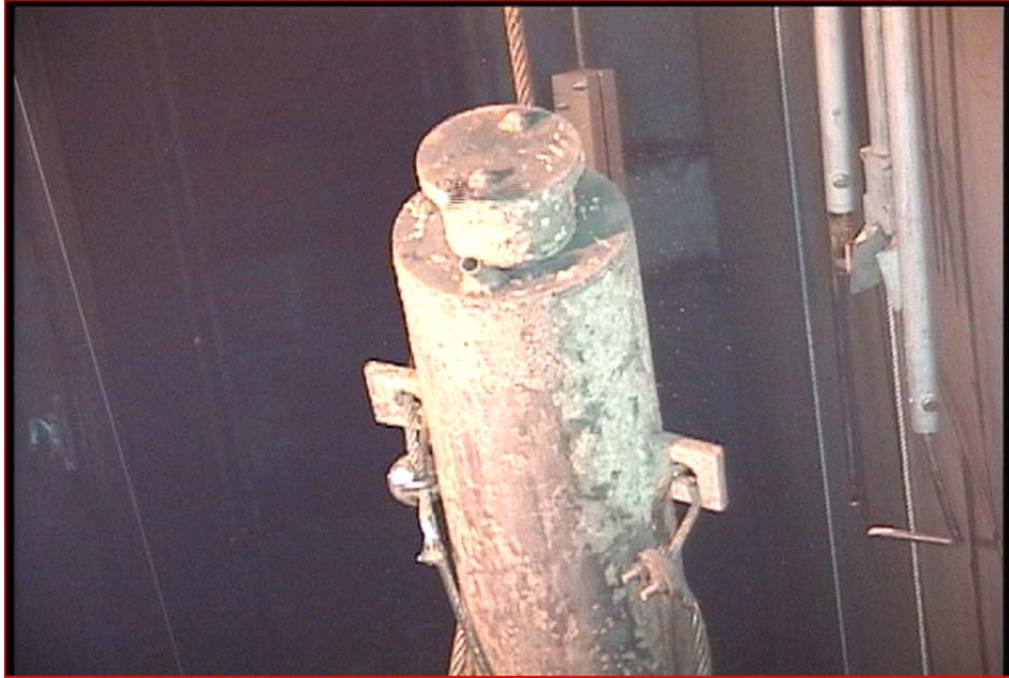
**Figure 13. Failed element container with evidence of pitting.**
