Integrity of Uranium Hexafluoride Cylinders

Defense Nuclear Facilities Safety Board

Technical Report

May 5, 1995

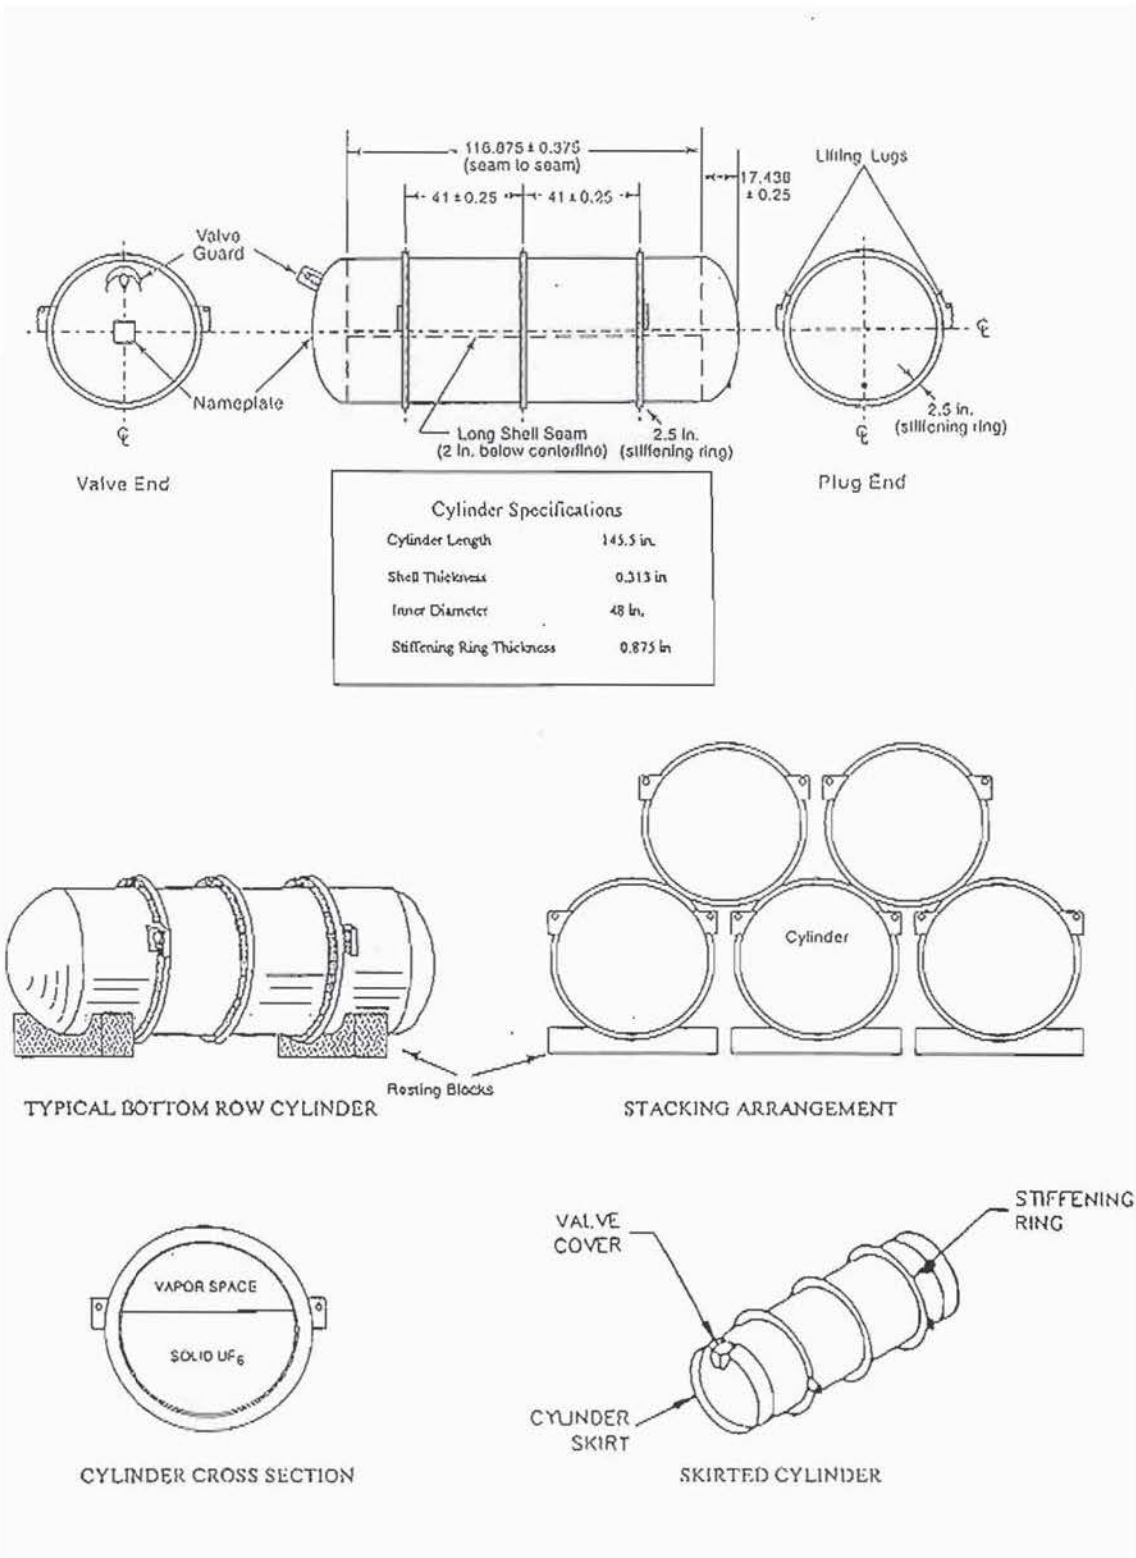
Various Cylinder Views
Figure 3

It does not appear that inspection methods, such as ultrasonic thickness measurements, are consistently being used in a manner that will provide needed information about the extent and rate of cylinder corrosion. For example, thickness measurements made on cylinders at K-25 were not correlated with the actual storage history of the cylinders (e.g., ground contact versus non-ground contact, or surfaces formerly on resting blocks). Also, ultrasonic measurements of the cylinders at K-25 and the bottom row of cylinders at Paducah were typically limited to spots that visually appeared to be the most corroded. Views and stacking arrangements of typical cylinders are shown in Figure 3.
