Part One

The Accident

Part One of the report of the Columbia Accident Investigation Board is organized into four chapters. In order to set the background for further discussion, Chapter 1 relates the history of the Space Shuttle Program before the *Challenger* accident. The events leading to the original approval of the Space Shuttle Program are recounted, as well as an examination of some of the promises made in order to gain that approval. In retrospect, many of these promises could never have been achieved. Chapter 2 documents the final flight of *Columbia*. As a straightforward record of the event, it contains no findings or recommendations. Chapter 3 reviews five analytical paths – aerodynamic, thermodynamic, sensor data timeline, debris reconstruction, and imaging evidence – to show that all five independently arrive at the same conclusion. Chapter 4 describes the investigation into other possible physical factors that might have contributed to the accident, but were subsequently dismissed as possible causes.

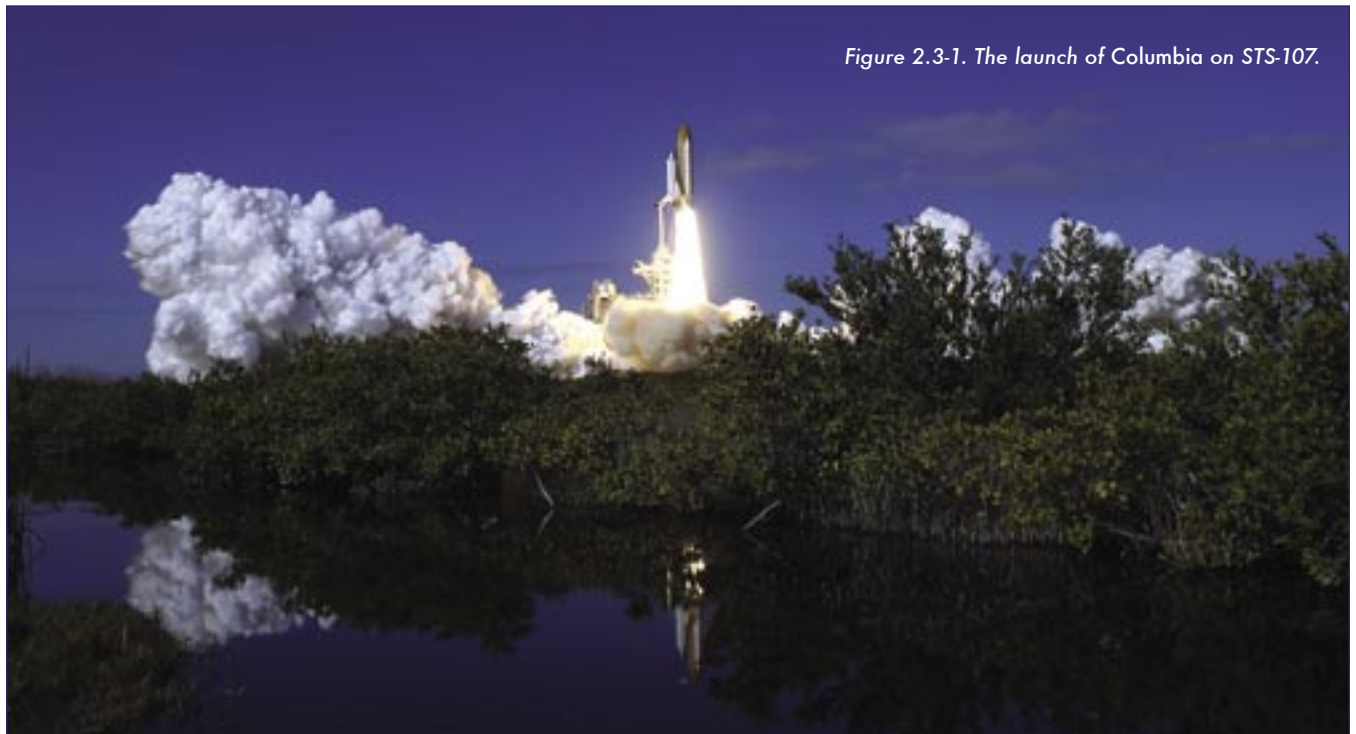
Figure 2.3-1. The launch of Columbia on STS-107.

Post-launch photographic analysis showed that one large piece and at least two smaller pieces of insulating foam separated from the External Tank left bipod (-Y) ramp area at 81.7 seconds after launch. Later analysis showed that the larger piece struck *Columbia* on the underside of the left wing, around Reinforced Carbon-Carbon (RCC) panels 5 through 9, at 81.9 seconds after launch (see Figure 2.3-2). Further photographic analysis conducted the day after launch revealed that the large foam piece was approximately 21 to 27 inches long and 12 to 18 inches wide, tumbling at a minimum of 18 times per second, and moving at a relative velocity to the Shuttle Stack of 625 to 840 feet per second (416 to 573 miles per hour) at the time of impact.

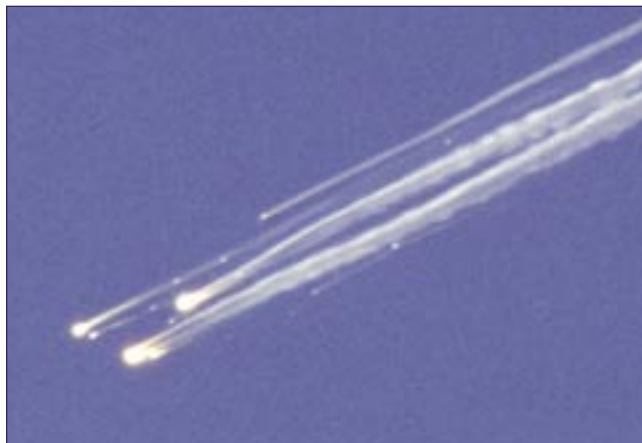
This view was taken from Dallas. (Robert McCullough/© 2003 The Dallas Morning News)

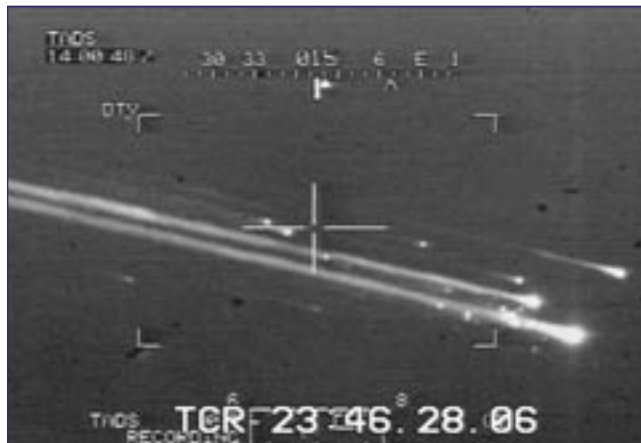
This video was captured by a Danish crew operating an AH-64 Apache helicopter near Fort Hood, Texas.

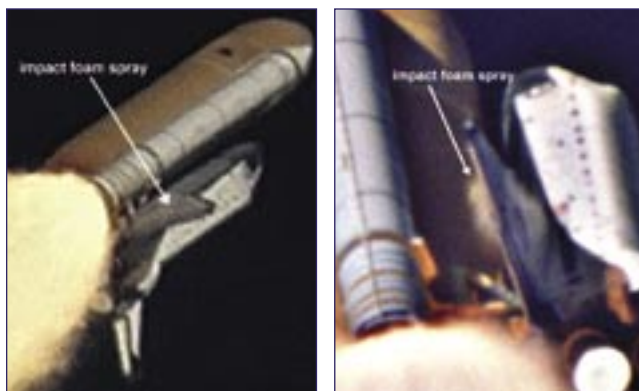
Figure 3.4-1 (color enhanced and "de-blurred" by Lockheed Martin Gaithersburg) and Figure 3.4-2 (processed by the National Imagery and Mapping Agency) are samples of the type of visual data used to establish the time of the impact (81.9 seconds), the altitude at which it occurred (65,860 feet), and the object's relative velocity at impact (about 545 mph relative to the Orbiter).

A 35-mm film camera, E212, which recorded the foam strike from 17 miles away, and video camera E208, which recorded it from 26 miles away, provided the best of the available evidence. Analysis of this visual evidence (see Figures 3.4-1 and 3.4-2) along with computer-aided design analysis, refined the potential impact area to less than 20 square feet in RCC panels 6 through 9 (see Figure 3.4-3), including a portion of the corresponding carrier panels and adjacent tiles. The investigation image analysis team found no conclusive visual evidence of post-impact debris flowing over the top of the wing.

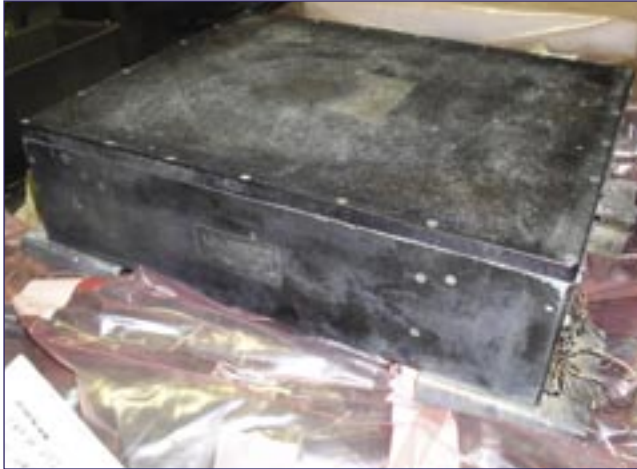
The Modular Auxiliary Data System is a supplemental instrumentation system that gathers Orbiter data for processing after the mission is completed. Inputs are almost exclusively physical sensor readings of temperatures, pressures, mechanical strains, accelerations, and vibrations. The Modular Auxiliary Data System usually records only the mission's first and last two hours (see Figure 3.6-1).

Figure 3.6-1. The Modular Auxiliary Data System recorder, found near Hemphill, Texas. While not designed to withstand impact damage, the recorder was in near-perfect condition when recovered on March 19, 2003.

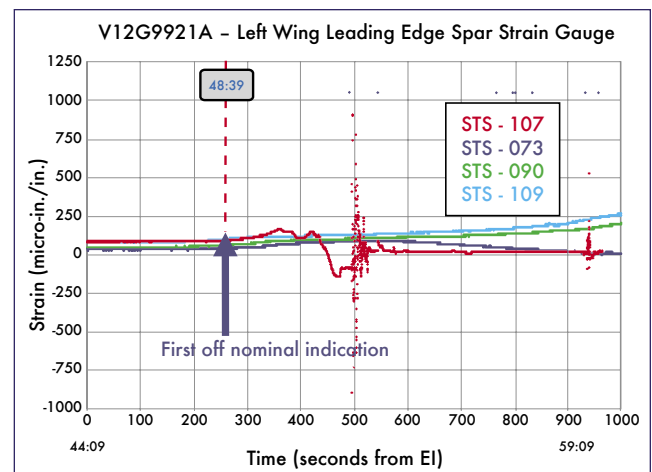
Figure 3.6-3. The strain gauge (Sensor 1) on the back of the left wing leading edge spar was the first sensor to show an anomalous reading. In this chart, and the others that follow, the red line indicates data from STS-107. Data from other *Columbia* re-entries, similar to the STS-107 re-entry profile, are shown in the other colors.

Sensor 1 provided the first anomalous reading (see Figure 3.6-3). From EI+270 to EI+360, the strain is higher than that on previous *Columbia* flights. At EI+450, the strain reverses, and then peaks again in a negative direction at EI+475. The strain then drops slightly, and remains constant and negative until EI+495, when the sensor pattern becomes unreliable, probably due to a propagating soft short, or “burn-through” of the insulation between cable conductors caused by heating or combustion. This strain likely indicates significant damage to the aluminum honeycomb spar. In particular, strain reversals, which are unusual, likely mean there was significant high-temperature damage to the spar during this time.

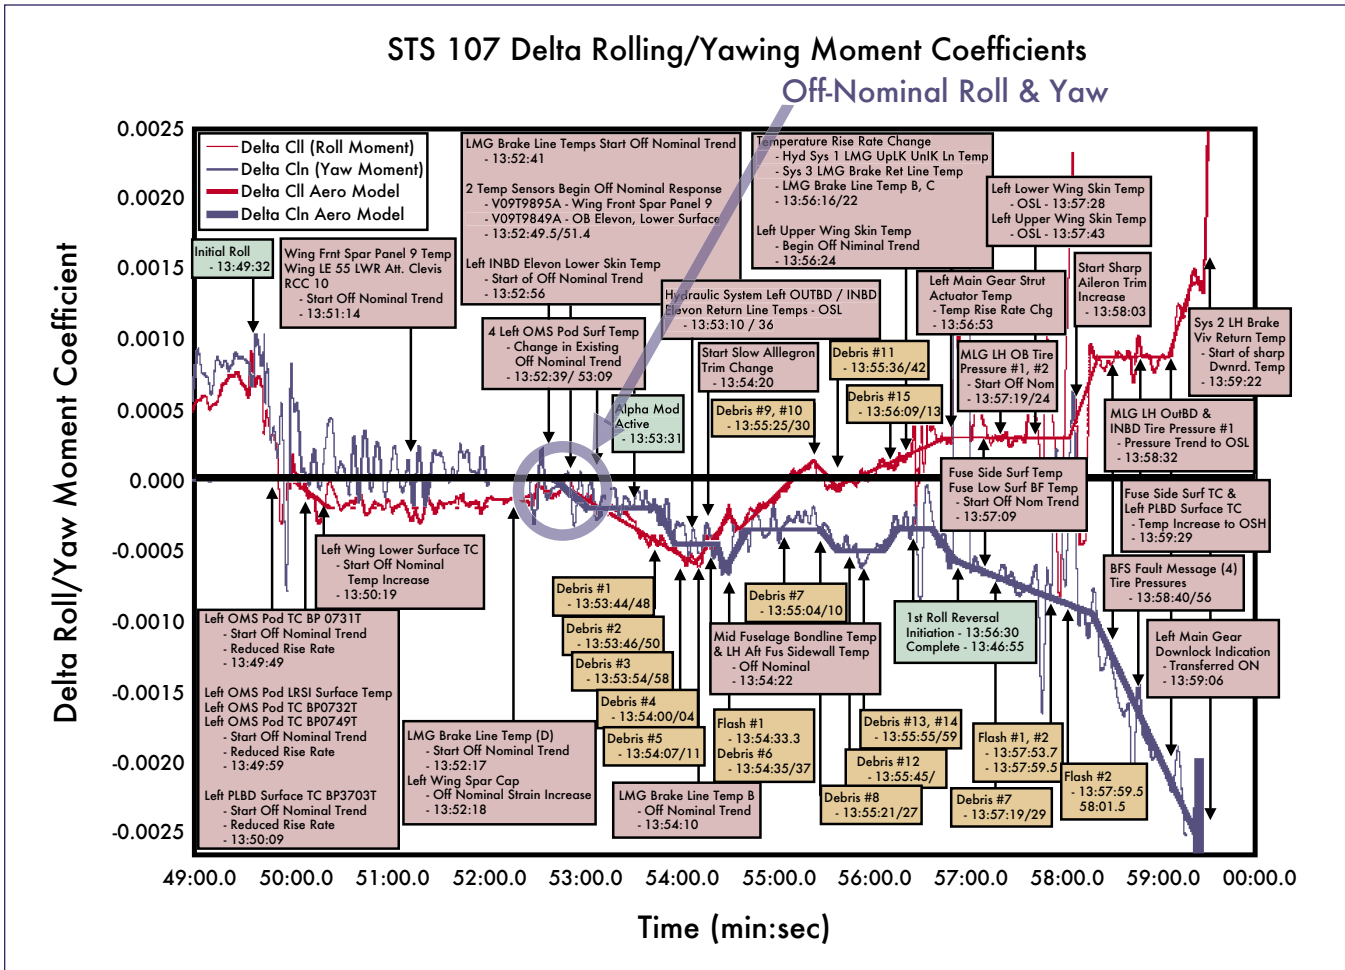
Aerodynamic roll and yaw forces began to differ from those on previous flights at about EI+500 (see Figure 3.6-12). Investigators used flight data to reconstruct the aerodynamic forces acting on the Orbiter. This reconstructed data was then compared to forces seen on other similar flights of *Columbia*

Figure 3.6-12. At approximately EI+500 seconds, the aerodynamic roll and yaw forces began to diverge from those observed on previous flights. The blue line shows the Orbiter’s tendency to yaw while the red line shows its tendency to roll. Nominal values would parallel the solid black line. Above the black line, the direction of the force is to the right, while below the black line, the force is to the left.

and to the forces predicted for STS-107. In the early phase of flight, these abnormal aerodynamic forces indicated that *Columbia’s* flight control system was reacting to a change in the external shape of the wing, which was caused by progressive RCC damage that caused a continuing decrease in lift and a continuing increase in drag on the left wing.

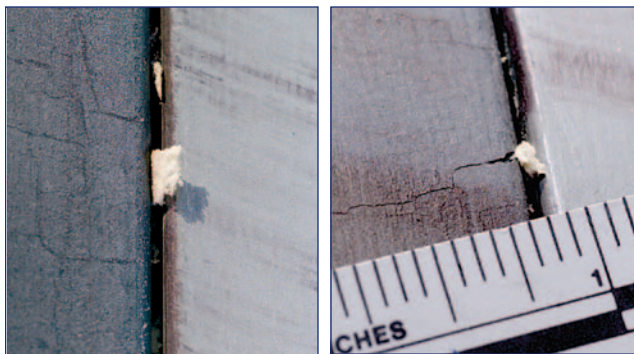
Figure 3.8-8. Two views of foam lodged into the slit during tests.

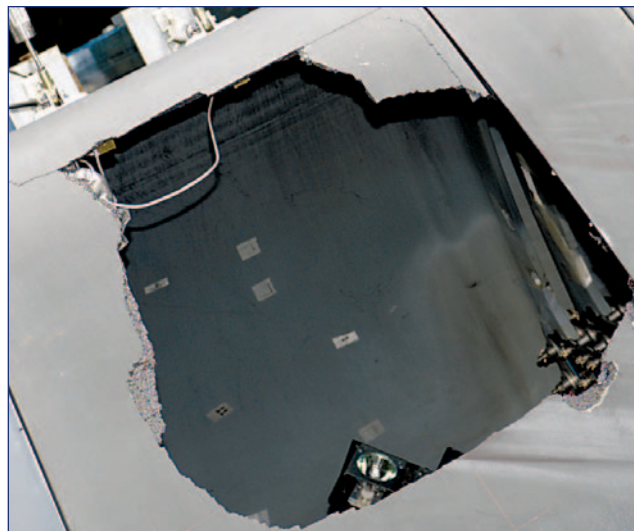
Figure 3.8-9. The large impact hole in Panel 8 from the final test.

The impact created a hole roughly 16 inches by 17 inches, which was within the range consistent with all the findings of the investigation (see Figure 3.8-9). Additionally, cracks in the panel ranged up to 11 inches in length (Figure 3.8-10). The T-seal between panels 8 and 9 also failed at the lower outboard mounting lug.

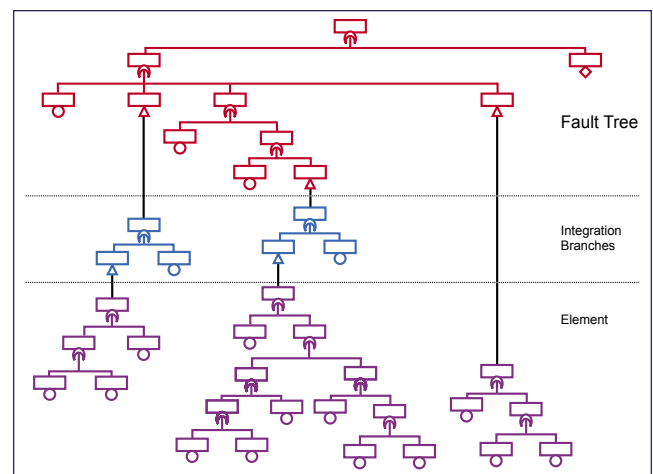
Figure 4.1-1. Accident investigation fault tree structure.

The NASA Accident Investigation Team investigated the accident using “fault trees,” a common organizational tool in systems engineering. Fault trees are graphical representations of every conceivable sequence of events that could cause a system to fail. The fault tree’s uppermost level illustrates the events that could have directly caused the loss of *Columbia* by aerodynamic breakup during re-entry. Subsequent levels comprise all individual elements or factors that could cause the failure described immediately above it. In this way, all potential chains of causation that lead ultimately to the loss of *Columbia* can be diagrammed, and the behavior of every subsystem that was not a precipitating cause can be eliminated from consideration. Figure 4.1-1 depicts the fault tree structure for the *Columbia* accident investigation.

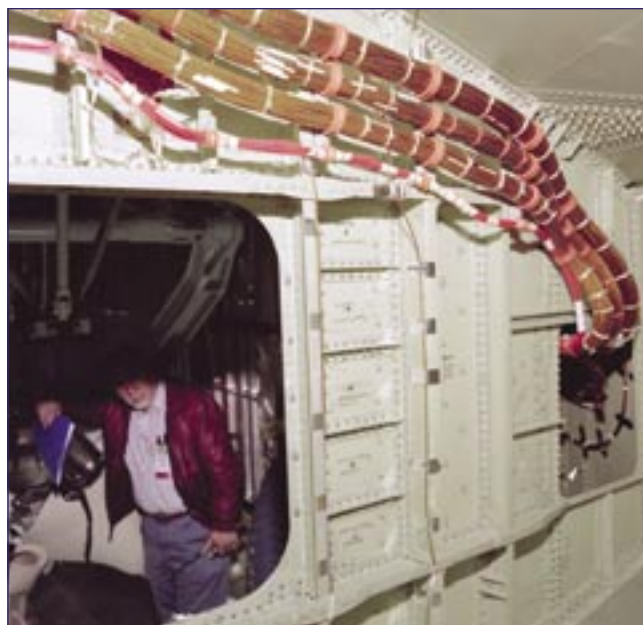
Figure 4.2-3. Typical wiring bundle inside Orbiter wing.

A typical wiring bundle is shown in Figure 4.2-3. Wiring nonconformances are corrected by rerouting, reclamping, or installing additional insulation such as convoluted tubing, insulating tape, insulating sheets, heat shrink sleeving, and abrasion pads (see Figure 4.2-4). Testing has shown that wiring bundles usually stop arc tracking when wires are physically separated from one another. Further testing under conditions simulating the Shuttle's wiring environment demonstrated that arc tracking does not progress beyond six inches. Based on these results, Boeing recommended that NASA separate all critical paths from larger wire bundles and individually protect them for a minimum of six inches beyond their separation points.⁴ This recommendation is being adopted through modifications performed during scheduled Orbiter Major Modifications. For example, analysis of telemetered data from 14 of *Columbia's* left wing sensors (hydraulic line/wing skin/wheel temperatures, tire pressures, and landing gear downlock position indication) provided failure signatures supporting the scenario of left-wing thermal intrusion, as opposed to a catastrophic failure (extensive arc tracking) of Kapton wiring. Actual NASA testing in the months following the accident, during which wiring bundles were subjected to intense heat (ovens, blowtorch, and arc jet), verified the failure signature analyses. Finally, extensive testing and analysis in years prior to STS-107 showed that, with the low currents and low voltages associated with the Orbiter's instrumentation system (such as those in the left wing), the probability of arc tracking is commensurately low.
