DEFENSE NUCLEAR FACILITIES SAFETY BOARD

SUBJECT: Report on the Radiation Protection Review at the Rocky Flats Plant

1. **Purpose:** This memorandum documents the Defense Nuclear Facilities Safety Board (DNFSB) technical staff and outside expert trip to the Rocky Flats Plant to review the Radiation Protection Program. The review was based on a visit to Rocky Flats on August 16-20, 1993.
2. **Summary:** The staff reviewed the Radiation Protection Program for consistency with Department of Energy (DOE) Order 5480.11, *Radiation Protection for Occupational Workers*, DOE Notice 5480.6, *Radiological Control*, and DOE Order 5400.5, *Radiation Protection of the Public and the Environment*.

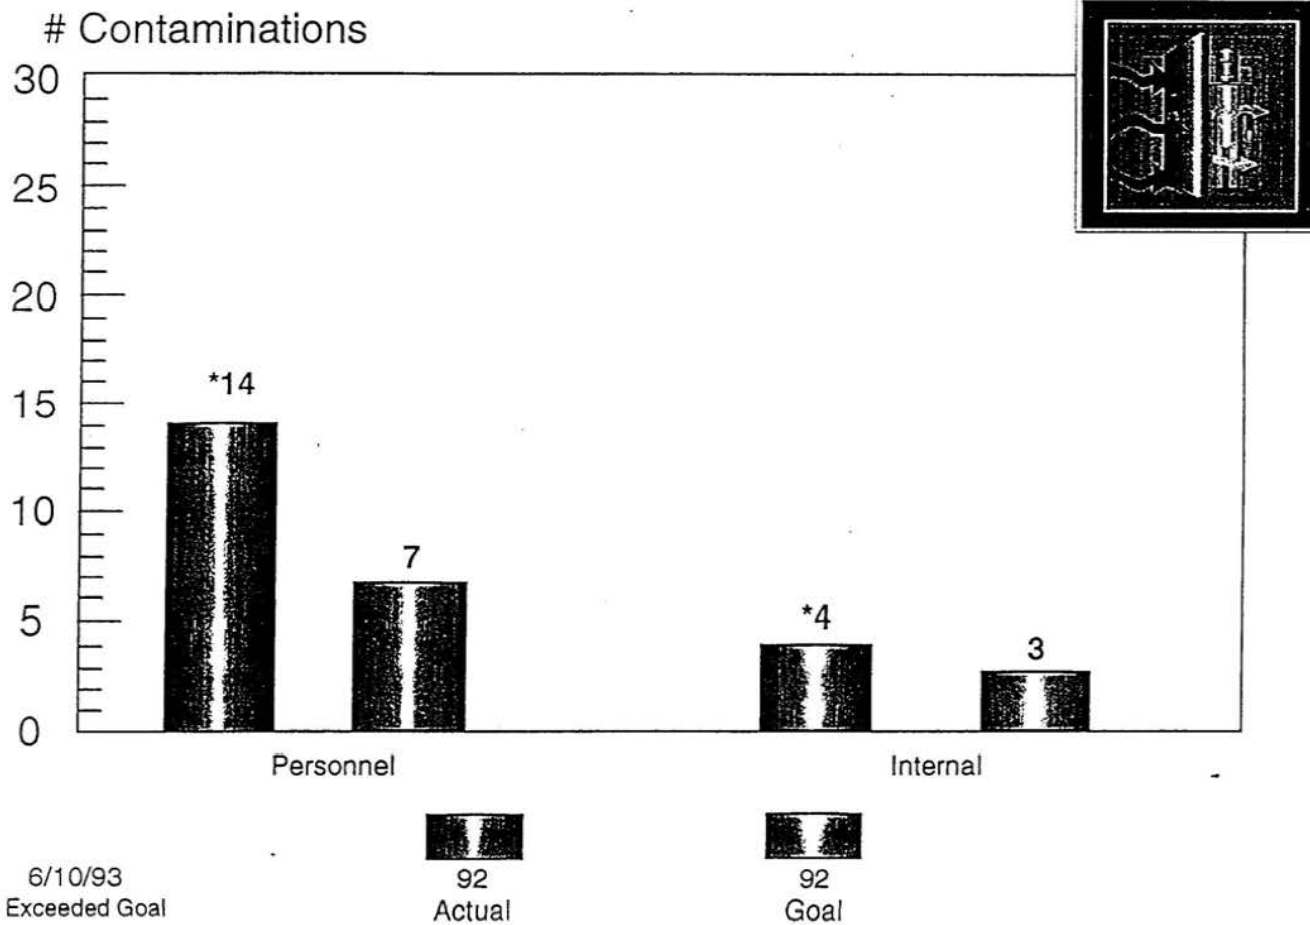
Personnel/Internal Contamination Totals

1992 ALARA Goals Summary

EG&G Rocky Flats

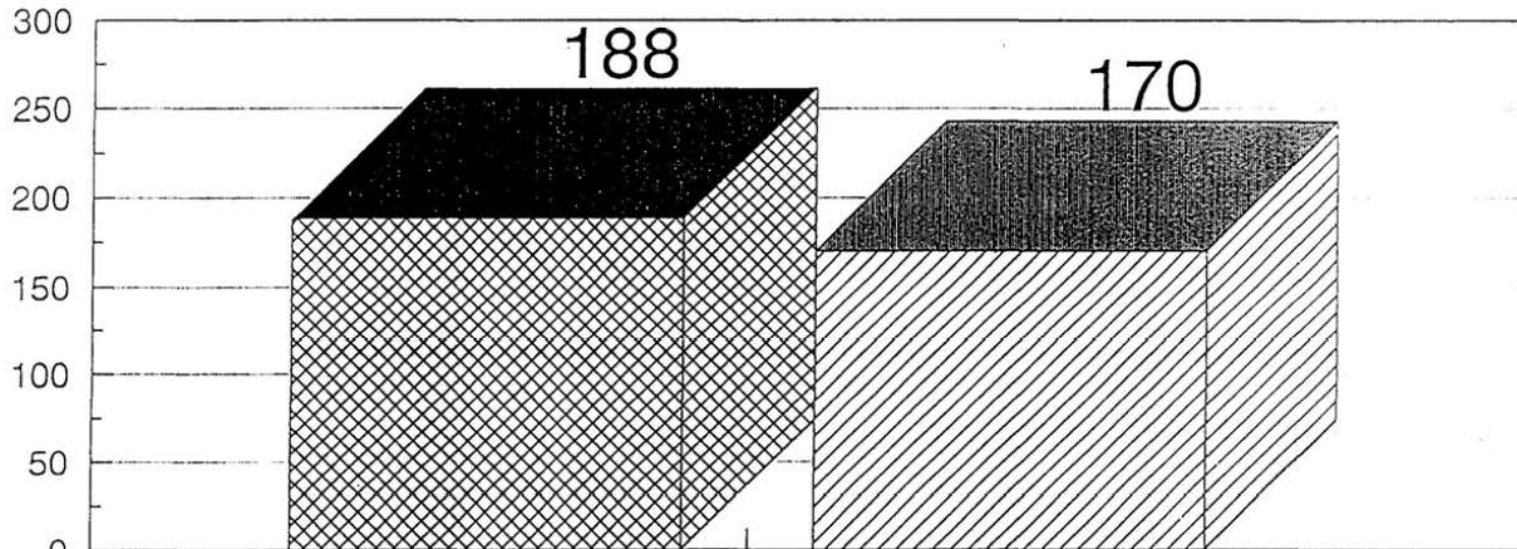
EG&G Rocky Flats Personnel Dose Totals

1992 ALARA Goals Summary

Person-Rem

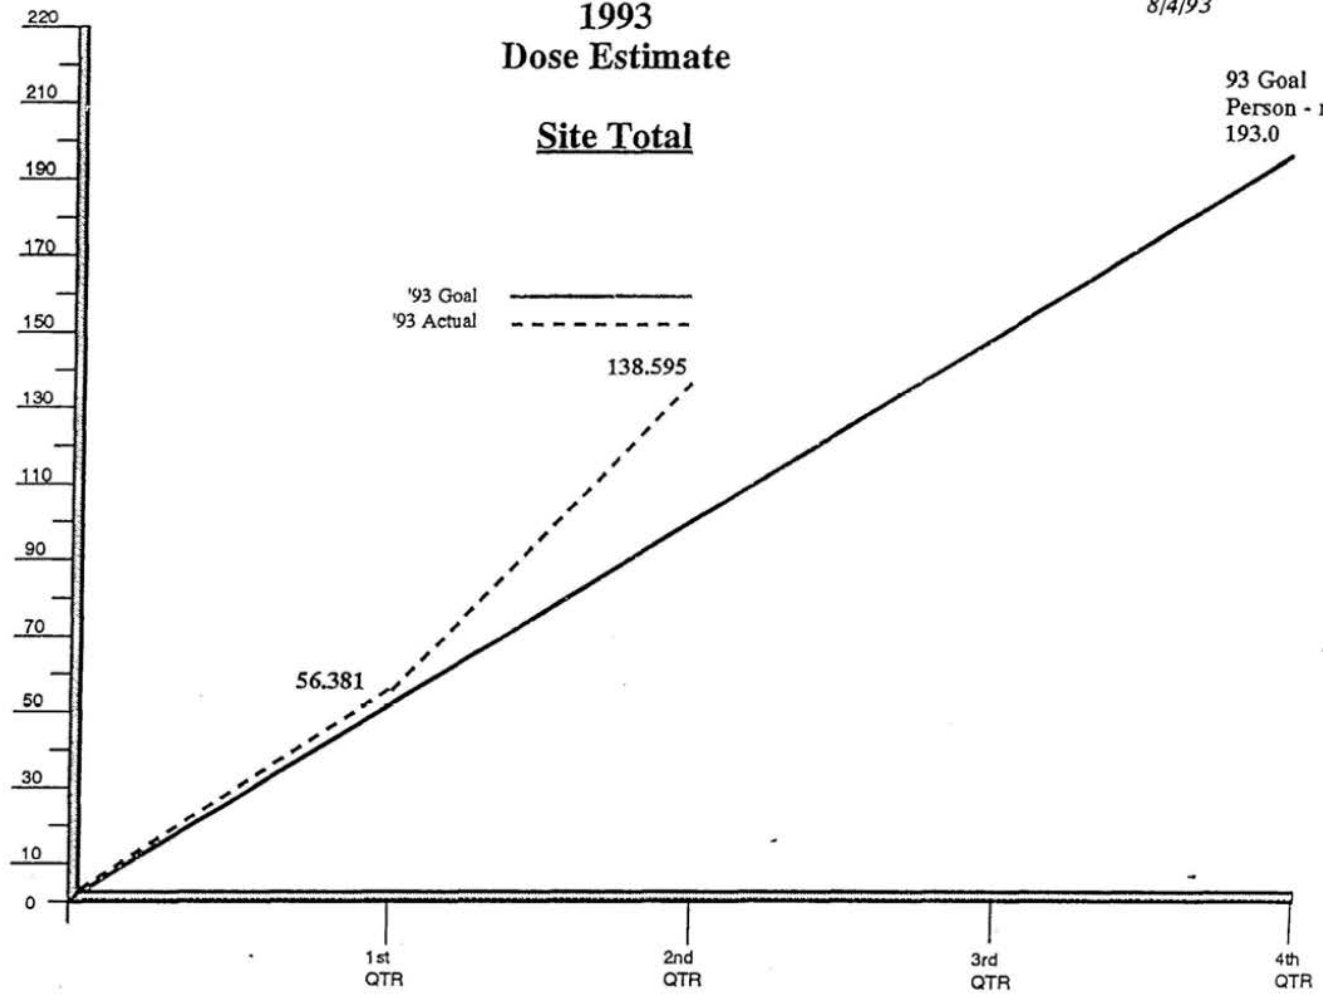
EG&G Person - rem 1993 Dose Estimate

Site Total

93 Goal
Person - rem
193.0

5. The method used for development of ALARA external exposure is without a strong foundation. Typically, the estimate of the previous year's external exposure total is simply factored down by 10 %. Allowances are not made for changes in work load or personnel staffing from year to year. Major changes in work assignments can significantly affect a groups external radiation exposure for a year. However, provisions apparently do not exist to adjust a goal during the year to account for these changes. These issues limit the usefulness of the goals as a management tool.
